Pipe spool repaired with Belzona SuperWrap II

ID: 10030

Industry: Water / Wastewater
Application: VPF-Valves, Pipes and Fittings
Substrate: Carbon steel
Products: Belzona 1212, Belzona SuperWrap II

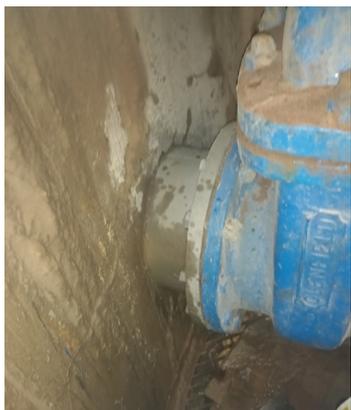
A large crack had formed in a pipe spool. This pipe was located deep within a reservoir sump & was impossible to remove without major structural works. A repair had to be put in place in-situ to prevent further leakage & to reinforce the area.

The leaking spool was built into the concrete sump wall - this went directly out to the reservoir.

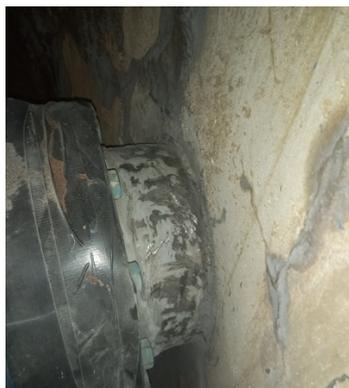
Surface preparation & application of Belzona 1212

The area was first grit blasted to SA2.5 & 75 microns. Belzona 1212 was then applied to any cracked areas. Four layers of Belzona SuperWrap II were then applied & consolidated using Belzona 9382.

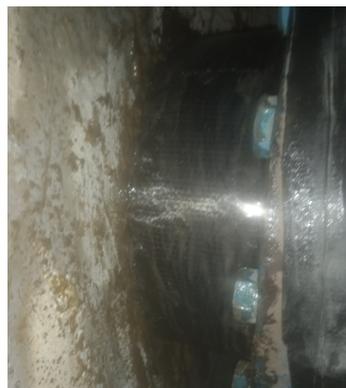
Layers of Belzona SuperWrap II applied

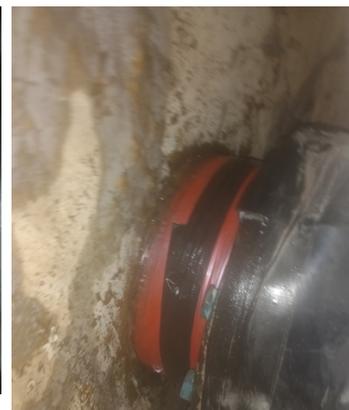
Repair consolidated

Belzona 1212 carried the WRAS approval required for water contact. Using the SuperWrap II system imparted additional strength to the pipe to reduce the chances of further cracking.
