BELZONA STEMS LEAK AND REPLACES FAILED SEWAGE TANK BASE SEAL

ID: 10031

Application: TCC-Tanks and Chemical Containment Areas

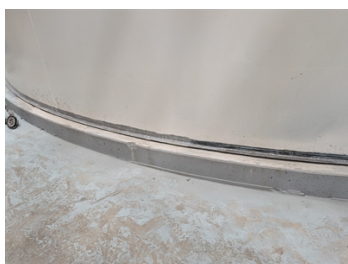
Tank base during surface preparation

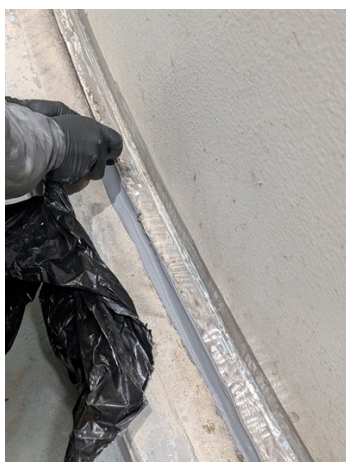
Stemming the leak with Belzona 1161

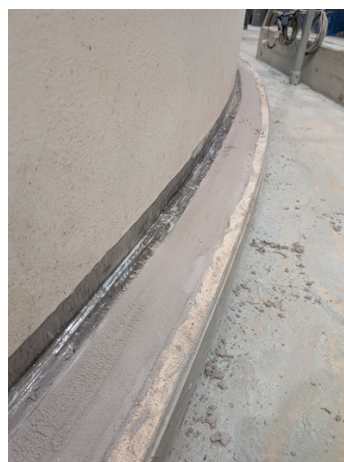
Sealing the perimeter with Belzona 4111

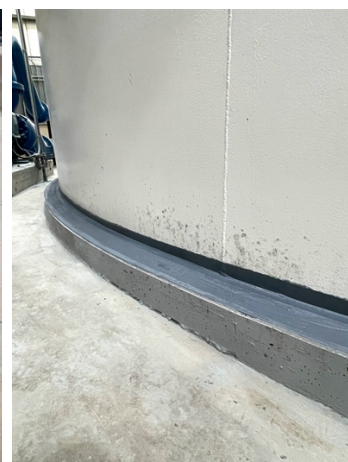
After application of two coats of Belzona 3111 with mesh.
