BELZONA HELPS REBUILD TOLERANCE LOSS DUE TO MILL SCALE

ID: 10032

Industry: Other
Application: GSS-Gaskets, Seals and Shims
Substrate: Carbon steel
Products: Belzona 1121 (Super XL-Metal)

Customer Location: CAMBRIDGE, ON.
Application Date: October 2025

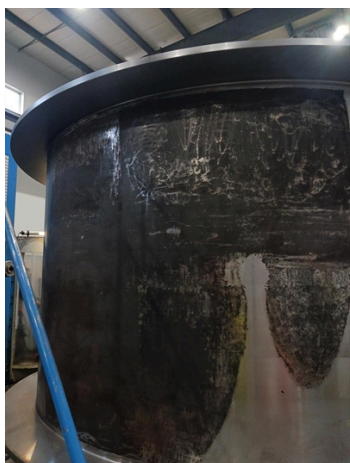
Newly fabricated cylinder experiencing reduction in diameter due to mill scale formation on some parts of the surface.

Cylinder with millscale

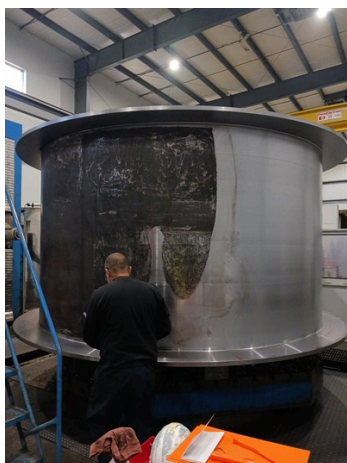
During surface preparation

Surface preparation was carried out to the level of cleanliness of SSPC SP11. Then thorough solvent cleaning was done before the application of Belzona 1121 was carried out. Surface was then machined to the required diameter afterwards.

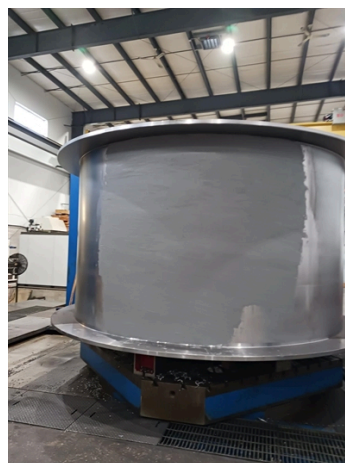
After rebuilding with Belzona 1121

Newly fabricated cylinder experiencing reduction in diameter due to mill scale formation on some parts of the surface. Belzona was used to build the surface and machined to the required tolerance.

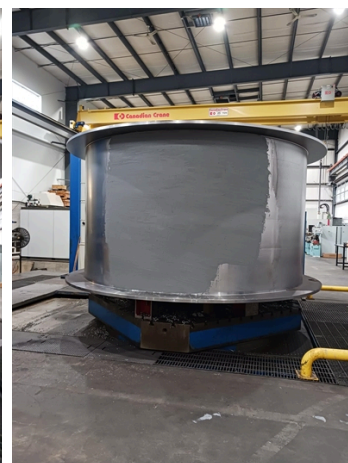
After machining
