Acid Containment Drain Coating with Belzona 4311

ID: 10035

Industry: Chemical & Petrochemical

Application: FPA-Floor Problem Areas

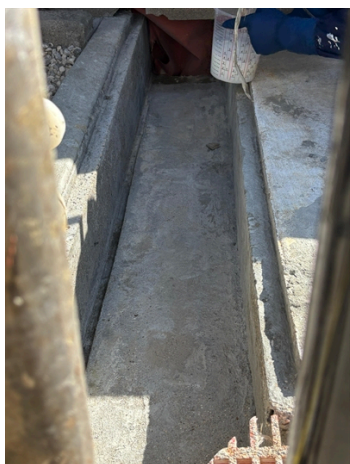
Image of the relatively new poured concrete drain area, before the coating work began

The customer recently repoured an area of concrete trench / drain that was previously eaten up from a sulfuric acid spill. The drain area has pipes in it that leaked onto the uncoated concrete and damaged it over time by chemical attack. After repouring the concrete drain area they wanted to line it to protect it from spills in the future.

We performed a moisture test with a protimeter to confirm moisture level was below 6%, on this relatively new poured concrete. We used handheld grinders with a turbocup diamond grinder attachment to prep the concrete. The grinder we used had a dust collection extraction shroud attachment on it to help collect dust. We applied Belzona products using stiff bristled nylon brushes, with bristles cut in half.

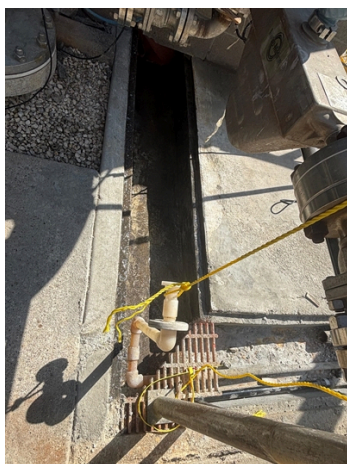
Belzona 4911 conditioner applied

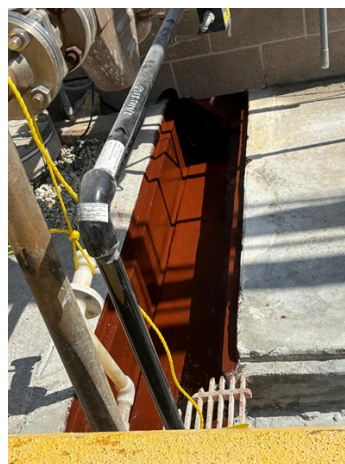
Belzona 4311 application complete

The Belzona solution should save the customer from any acid spill eating away their concrete drain if it happens in the future. If an acid spill were to get into the ground there would be numerous fines and safety concerns. It could also create downtime in their process, which creates unwanted financial loss. The 4311 system will provide a chemical resistant barrier from sulfuric acid attack.

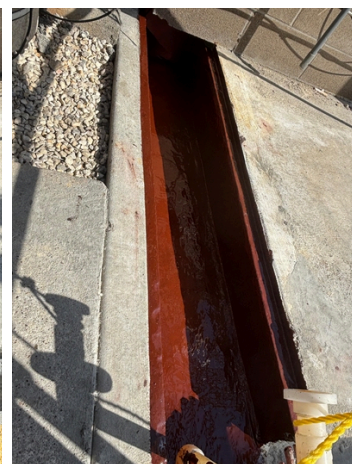
Belzona 4311 application complete
