Stairwell saved by Belzona membrane

ID: 10037

Application: RPA-Roof Problem Areas

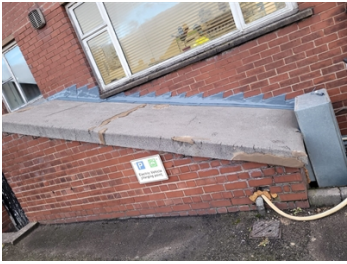
The mineral felt had disbonded from the base substrate and the lead flashings had detached from the wall on the slanting roof area of a stairwell

Slanting roof area showing failures to existing waterproofing

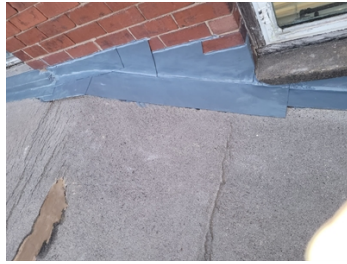
Stripe coat of Belzona 3131 applied following conditioning of lead using Belzona 3921

Belzona 3921 GSC was applied to the lead areas with no conditioner necessary for the main mineral felt areas

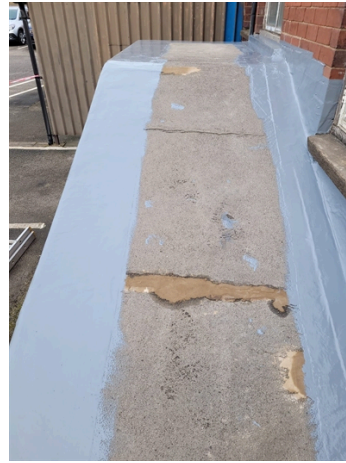
Edges complete and awaiting main membrane application

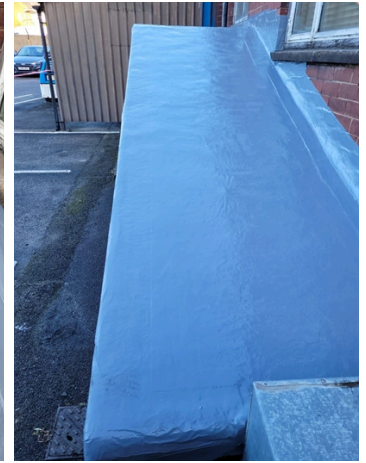
Completed works

2 coats of Belzona 3131 Winter Grade were applied complete with Belzona 9361 reinforcing sheet
