Belzona seals difficult to reach roof void

ID: 10039

Industry: General Industry
Application: RPA-Roof Problem Areas
Substrate: Carbon steel
Products: Belzona 3131 (WG Membrane), Belzona 3921 (GSC Surface Conditioner)

Customer Location: Pinxton
Application Date: November 2023

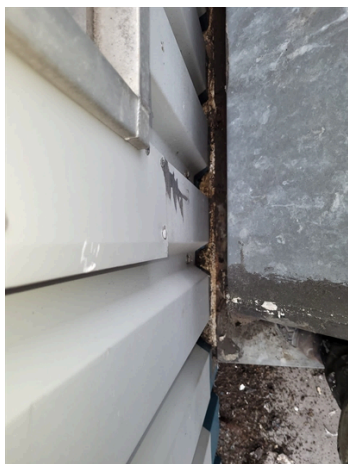
Leaks and issues were identified, originally emanating from an area of the roof which was extremely difficult to access, due to it's size, depth and position

A repair was needed to be made at a depth, almost out of each

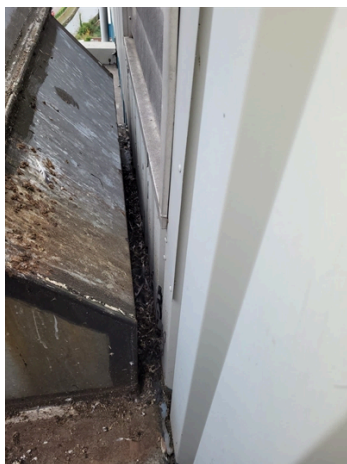
It wouldn't have been possible to offer a solution any other way than a flexible membrane. Belzona 3131 was chosen

A coat of 3921 was applied to the area , followed by 2 coats of Belzona 3131 with 9361 reinforcing sheet in place

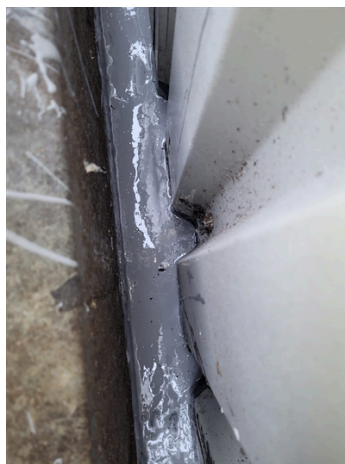
Belzona 3131 was the ideal choice for this difficult task

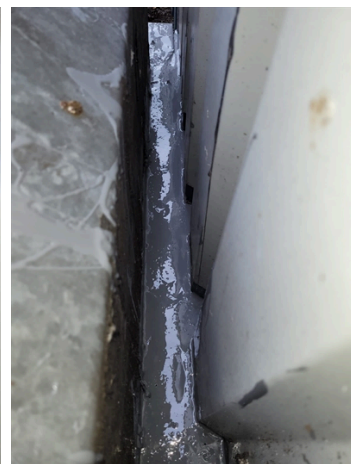
All complete with the deep void completely sealed
