# Belzona protects flare stack vessels for large oil refinery site

ID: 10042

Application: TCC-Tanks and Chemical Containment Areas

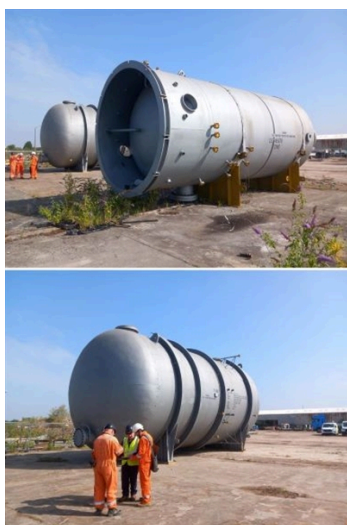
Showing the exterior of both vessels. An idea of size of vessels can be judged by the staff in the image. 350+ sqm internal walls across both vessels.

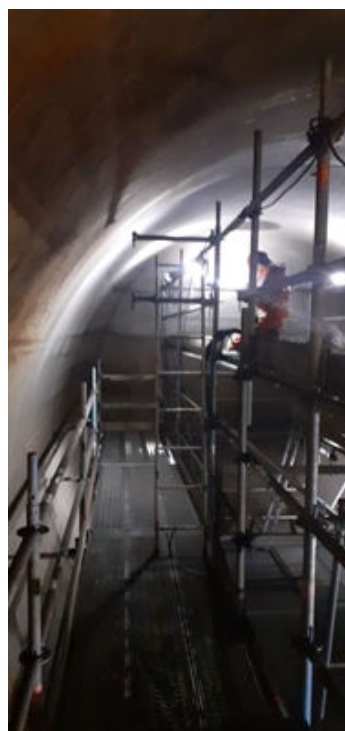
Internal of smaller vessel, showing scaffolding for top half of the vessel. The smaller vessel had internal fixtures that also required protective coating.
