# Louisiana Channel's the Belzona 5821

Industry: *Power*  
Application: *HEX-Heat Exchangers*  
Substrate: *Carbon steel*  
Products: *Belzona 1121 (Super XL-Metal), Belzona 5821*

Customer Location: *Lena Louisiana*  
Application Date: *October 2025*

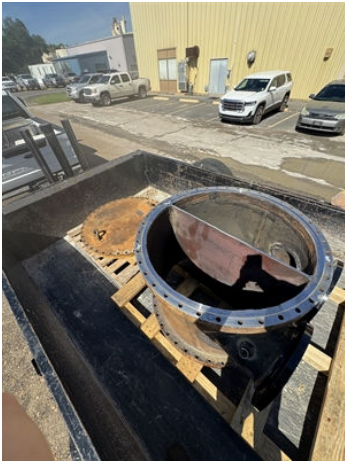
*Corroded and pitted channel head, divider plate and end cover*

When the channel head was delivered
