# Belzona Tackles positional repairs to machine damaged wall

ID: 10045

Industry: Power

Application: WPA-Wall Problem Areas

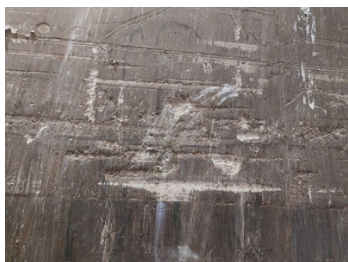
A large wall had continued to sustain damage through impact with loader shovels and payloaders in the tipping hall of a large Energy from Waste site. It was decided to use Belzona MagmaBuild 4141 as a solution and offer sizeable repairs

Closer view of the damage sustained by the payload bucket impact

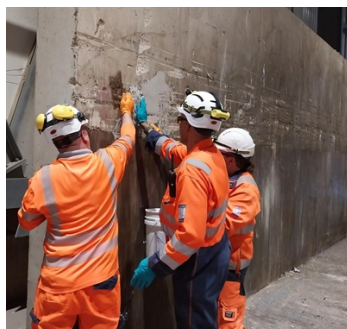
Colleagues setting about the repair to the wall

The wall was prepared by brushing, ensuring that all loose and friable materials were removed

The target areas were coated with Belzona 4911 TX Conditioner

The Belzona 4141 was mixed as per the IFU and applied by gloved hand, building up the volume until being troweled by a finishing trowel

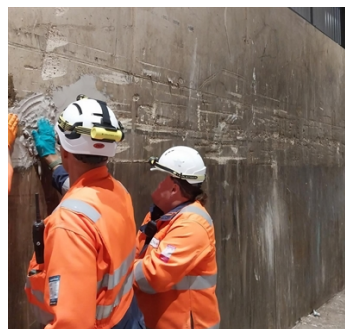
Training taking place for the in-house colleagues to learn the application process

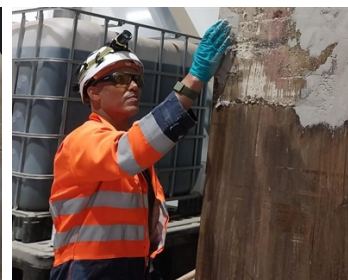
Finishing touches to complete the application training
