# Sloping walkway get's Belzona "Surefoot" system

ID: 10046

Industry: General Industry  
Application: FPA-Floor Problem Areas  
Substrate: Concrete  
Products: Belzona 5231 (SG Laminate), Belzona 9221 (Surefoot Aggregate White)

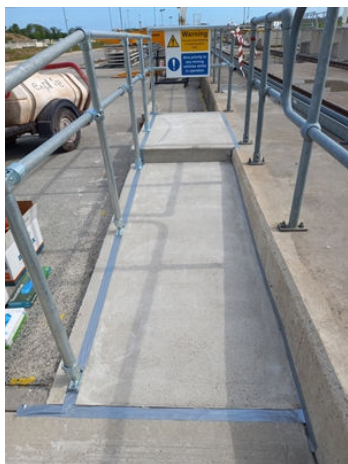
A small sloping external walkway had proven hazardous during the previous winter and it was decided to improve the basic concrete surface using Belzona products.

Walkway prior to commencement

The surface was prepared and cleaned, leaving a clean, dry and firm surface.

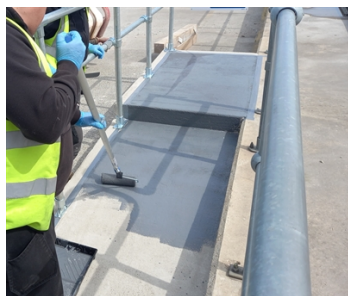
Applying Belzona 5231

The Belzona 5231 was mixed and the first coat applied, after which around 2Kg per m2 of Belzona 9221 Surefoot aggregate was scattered into the wet surface.

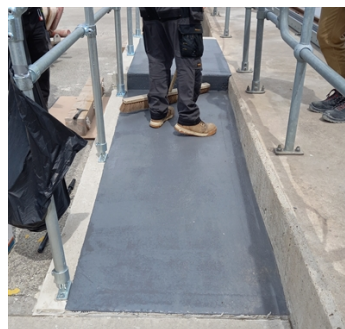
Works advancing

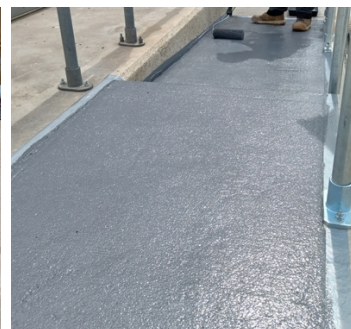
Completing the application

A further coat of Belzona 5231, being a different shade, was applied over the top of this to completely encapsulate the surface, leaving a safe, non-slip durable finish.
