Belzona Saves Bow Thruster Tunnel from Electrolysis

ID: 10047

Industry: Marine
Application: SOS-Ships and Offshore Structures

Customer Location: Morgan City, La
Application Date: September 2025

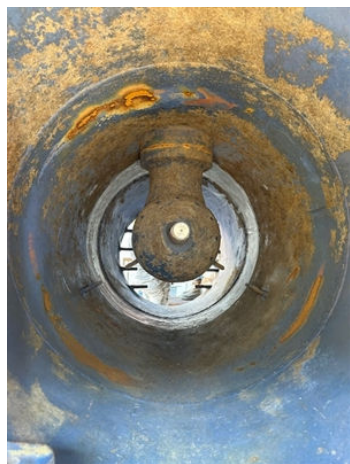
Bow thruster tunnel suffering from pitting due to electrolysis.

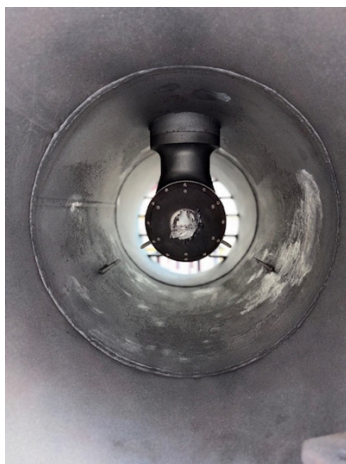
Bow thruster tunnel blasted to required SSPC-SP10.

Tunnel was blasted to SSPC-SP10 requirements. Tunnel was then cleaned with Belzona 9111 and allowed to dry. Belzona 1311 was then hand applied with applicators and short bristle brushes to fill in all pitting. Belzona 1321 1st coat was applied gray and then followed by 2nd coat of blue.

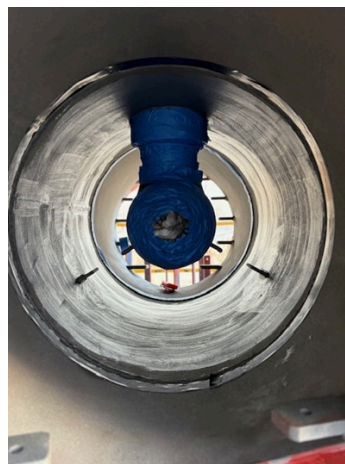
Belzona 1311 used to fill all pitting in tunnel.

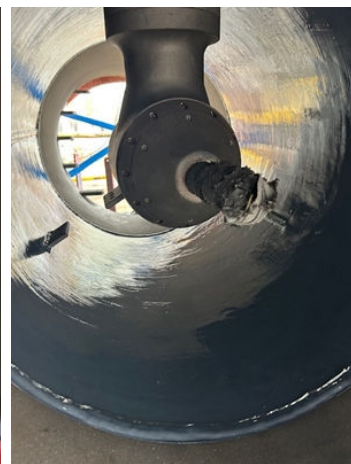
Job completed after 2nd coat of Belzona 1321 coating.
