Belzona stems leak and repairs ground water clarifier nozzle

ID: 10049

Application: *VPF-Valves, Pipes and Fittings*

Substrate: *Carbon steel*

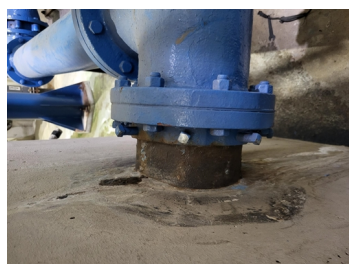
Ground water clarifier nozzle and parts on the tank close to it were leaking and required stemming the leak and repairing the eroded parts.

Before surface preparation.

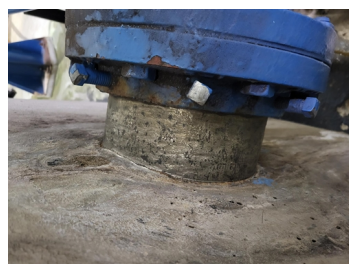
After surface preparation

Repair area was cleaned using power tool according to the SSPC SP 11 guidelines with solvent cleaning afterwards. After drying, Belzona 1161 was impregnated into the surface using a short bristled brush before the mesh Belzona 9341 was wetted with the material and wrapped round the area. More Belzona 1161 was applied to fully encapsulate the mesh. Belzona 5831 was applied afterwards to help against ingress of moisture and water.

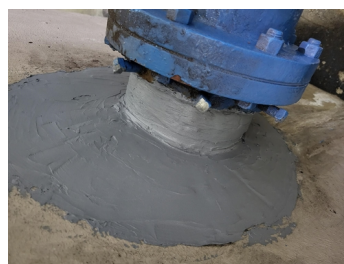
After application of Belzona 1161
