Belzona stems leak and repairs ground water clarifier nozzle

ID: 10049

Application: *VPF-Valves, Pipes and Fittings*

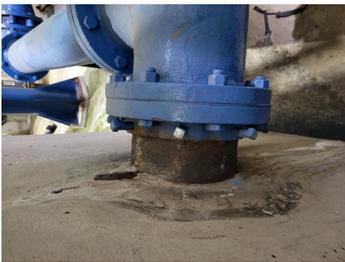
Ground water clarifier nozzle and parts on the tank close to it were leaking and required stemming the leak and repairing the eroded parts.

Before surface preparation.

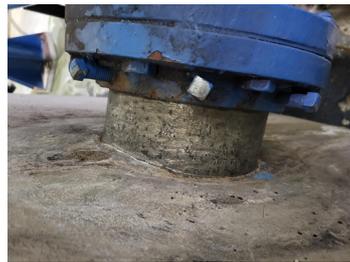
After surface preparation

Repair area was cleaned using power tool according to the SSPC SP 11 guidelines with solvent cleaning afterwards. After drying, Belzona 1161 was impregnated into the surface using a short bristled brush before the mesh Belzona 9341 was wetted with the material and wrapped round the area. More Belzona 1161 was applied to fully encapsulate the mesh. Belzona 5831 was applied afterwards to help against ingress of moisture and water.

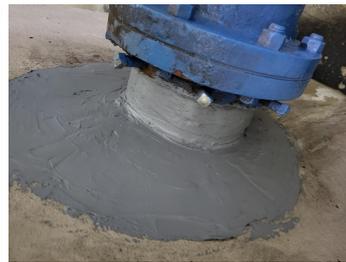
After application of Belzona
1161

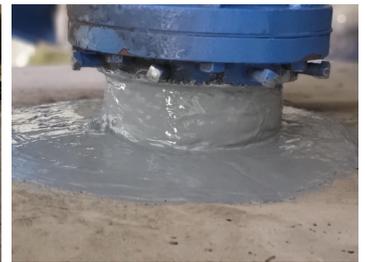
After application of Belzona
5831
