# BELZONA, ALTERNATIVE TO REPLACEMENT OF PIPE BENDS

ID: 1005

Customer Location: Coal-fired powerplant, Croatia

Products: Belzona® 1812 (Ceramic Carbide FP)

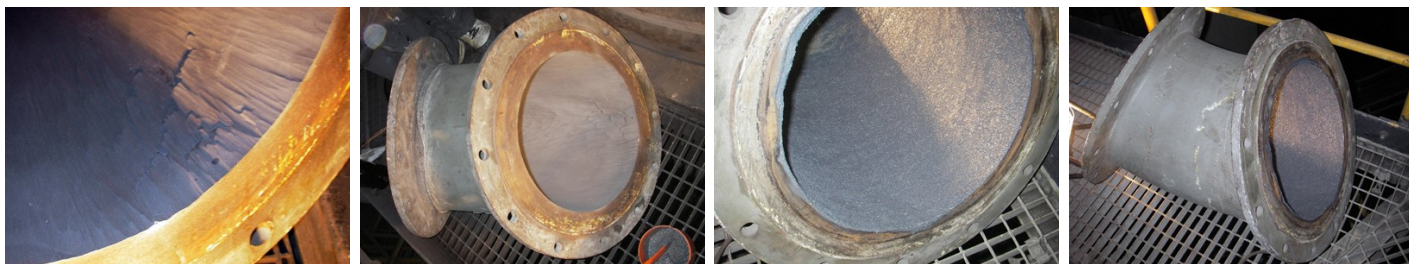
## Photograph Descriptions

Severe erosion damage to pipe bend linings due to the angle and force of coal dust hitting the inner surface of the pipe.

\* Damaged pipe close up , \* Damaged pipe , \* Applied Belzona® 1812 , \* Application finished ,

Application was carried out in accordance with Belzona Know-How System Leaflet SHM-8.

An initial test proved the cost benefit of the application to the customer during 6 months test period. Belzona® 1812 product acted as a wear surface with minimal metal loss recorded.
