Passenger ferry engine cylinder repair

ID: 10053

Industry: Marine
Application: ENC-Engines and Casings
Substrate: Carbon steel
Products: Belzona 1311 (Ceramic R-Metal)

Customer Location: Scotland, UK
Application Date: January 2021

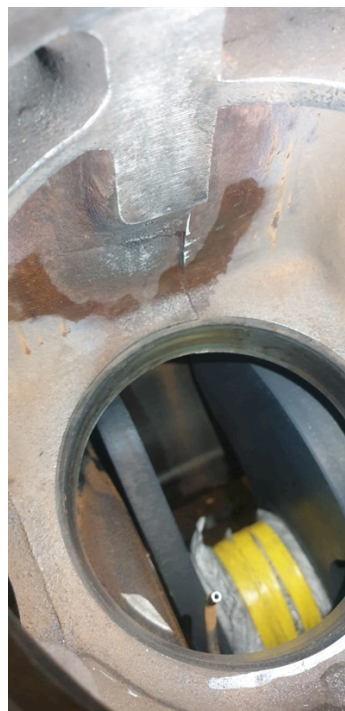
An engine used to run one of the bow thrusters was found to have damage within its engine cylinders. This was suspected to be caused by cavitation between the wall & the cylinder liners.

Vessel docked during overhaul Damaged area identified

The identified areas were ground out using an angle grinder. Belzona 1311 was then applied 'proud' of the lost metal. Once the product had reached its initial cure stage it was then machined down flat with the metal.

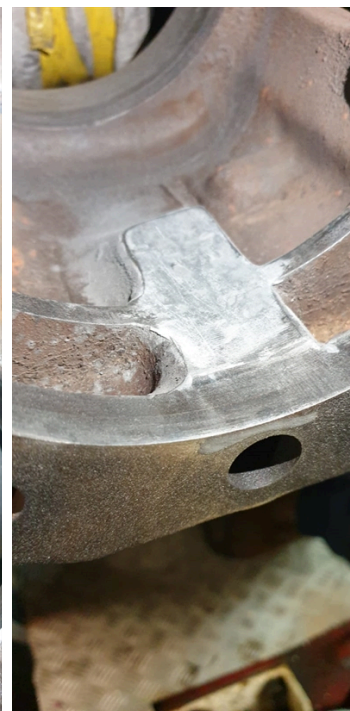
Belzona 1311 applied & then machined flat with the surrounding metal
