# Plastic tank pipe repairs

ID: 10055

Industry: Power  
Application: TCC-Tanks and Chemical Containment Areas  
Substrate: PVC  
Products: Belzona 1221 (Super E-Metal), Belzona 1981 (SuperWrap II)

Customer Location: Scotland, UK  
Application Date: May 2023

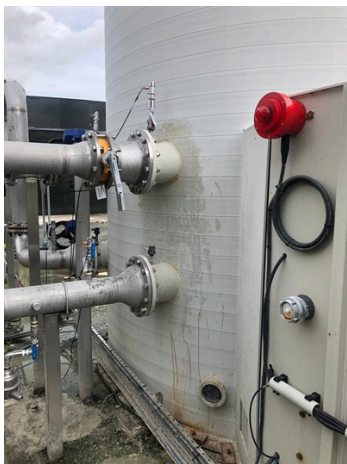
A plastic tank had developed several cracks around pipes. A replacement was planned but to get production through to that point a temporary fix was requested.

Leaking area

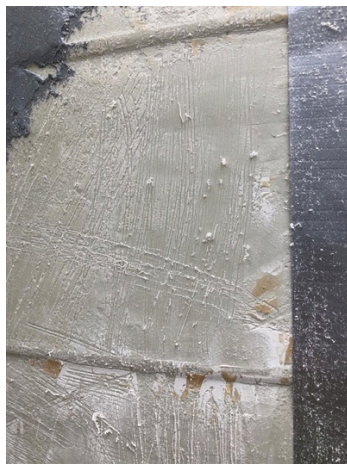
Surface preparation on the plastic tank

A repair was developed using roughening brushes on the plastic substrate & Belzona 1221 to yield best possible adhesion.

The area around the crack was roughened, Belzona 1221 applied. Belzona Superwrap 2 was then applied on top to impart more flexural strength to the repair.

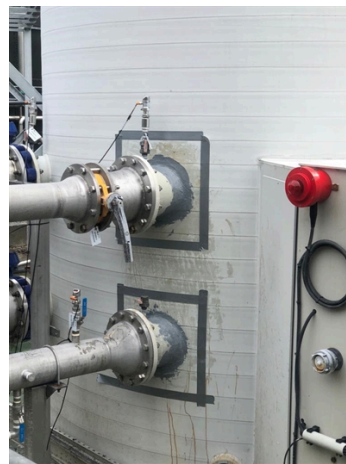
Belzona 1221 applied

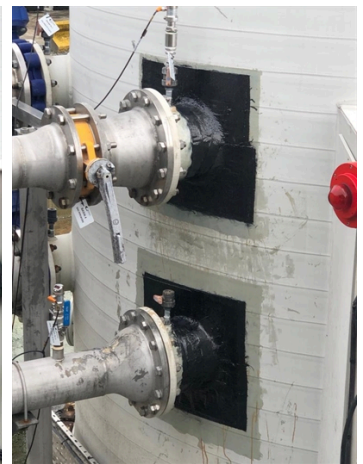
Belzona SuperWrap II system applied
