BELZONA GIVES OLD PUMP NEW LEASE OF LIFE

Application: CEP-Centrifugal Pumps

Customer Location: Coal-fired power plant, Croatia

Sea Water Pump

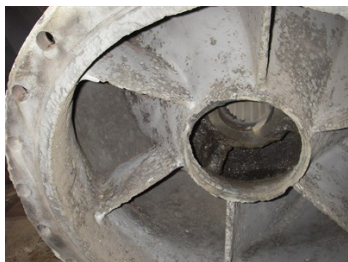
Deterioration due to bimetallic corrosion and sea water erosion.

* Damaged seawater pump , * Applying Belzona® 1311 , * Belzona® 1311 application complete , * Belzona® 1321 applied ,

Application was carried out in accordance with Belzona Know-How System leaflets CEP-3 & -5.

Due to the pump's condition, a new pump was considered but Belzona application proved to be a long term cost effective alternative.
