# Damage from Trailer landing legs, repaired by Belzona

ID: 10073

Application: FPA-Floor Problem Areas

Substrate: Concrete

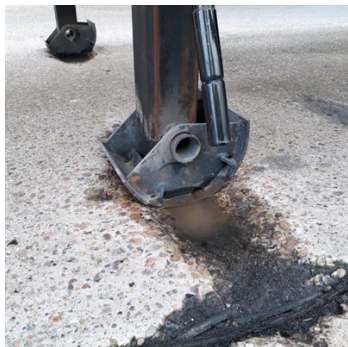
The Landing legs on the 40' trailers had worn depressions into the concrete floors. These were causing problems with fork lift traffic and other vehicles as some of the depressions were over 40mm deep

Showing landing legs causing wear to concrete parking area near loading doors

Areas cleaned and dried, the conditioned with Belzona 4911

Completed with Belzona 4131 and feather edged
