# Concrete repairs to heavy manufacturing floor

ID: 10074

Application: FPA-Floor Problem Areas

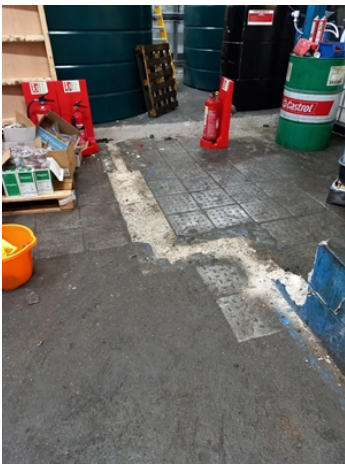
Areas of a heavy industrial floor were compromised and had started to break up, some of which had been repaired previously, though these repairs had failed

Showing one of the heavily damaged areas

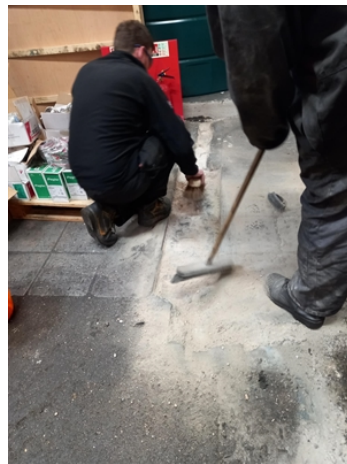
Cleaning area prior to application

Clean all area

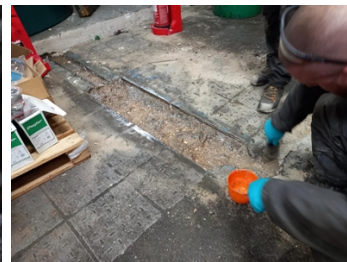
Application of Belzona 4911 TX Conditioner

Mix and apply Belzona 4911 TX conditioner

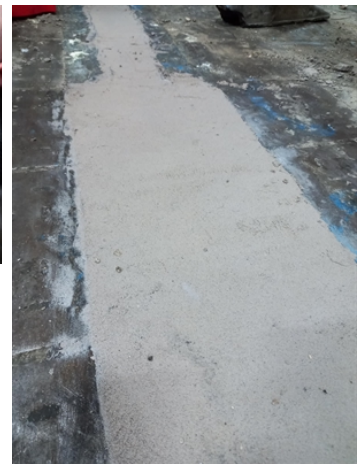
Completed application using Belzona 4131

Mix and apply Belzona 4131

The local Belzona ASR supported to application and trained the in-house colleagues on the proper procedure to effect a concrete repair. The site was visited earlier this year (2025) and found to be in excellent order
