Belzona Protects a Dryer Roller in a Paper Manufacturing Plant

ID: 10077

Industry: *Pulp & Paper*

Customer Location: *Jeddah, Saudi Arabia*

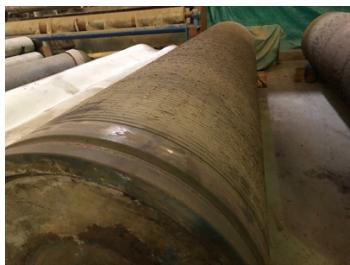
The dryer roller surface was suffering from severe corrosion due to the chemicals used in the wash solution coupled with elevated temperature and high humidity.

Corroded dryer roller caused by chemical washing, high temperature and humidity

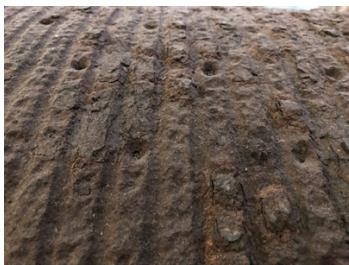
Close-up view of corroded dryer roller surface

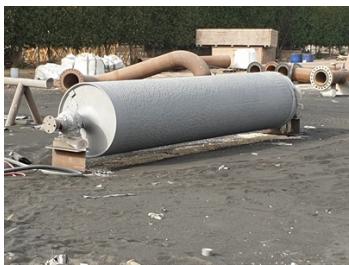
Surface preparation via abrasive grit blasting

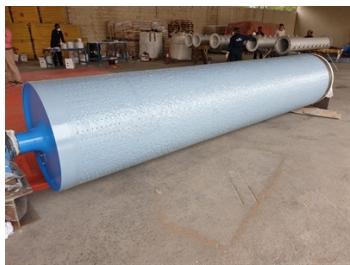
Dryer roller after the application of Belzona 1511 (Super HT-Metal) and Belzona 1391T to restore metal loss

Belzona 1511 (Super HT-Metal) was applied to rebuild and restore areas of significant metal loss on the dryer surface, effectively reinstating its original profile and structural integrity. Following the repair, Belzona 1391T, a high-performance, high-temperature resistant coating, was applied to the entire repair area. This coating provides long-term protection against corrosion, erosion, and chemical attack, ensuring enhanced durability and extending the operational life of the dryer under demanding service conditions.
