Concrete repair to roller shutter entrance repair

ID: 10079

Application: FPA-Floor Problem Areas

Substrate: Concrete

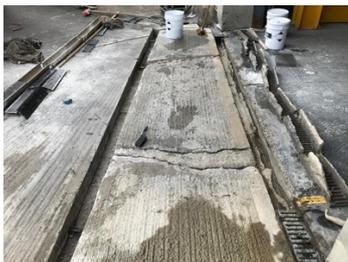
Constant heavy traffic had caused wear and damage to the apron leading toward the entrance of a large roller shutter door. The FLT were vibrating and unseating their loads, making the area dangerous for Forklift Traffic and anyone in the immediate area

Showing wear and heavy damage to the area

Break out all loose and friable

Vacuum the whole area

Apply Belzona 4911 as per Belzona 4131 IFU

Mix and apply Belzona 4131 as per Belzona 4131 IFU

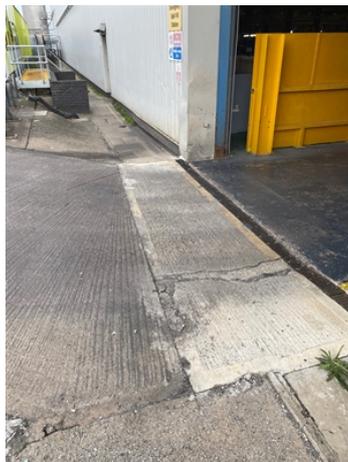
Further view of damage

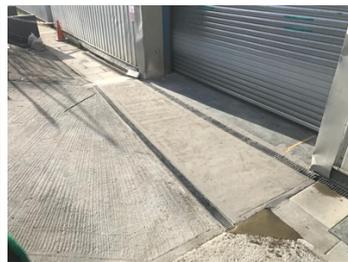
Completed repair using Belzona 4131

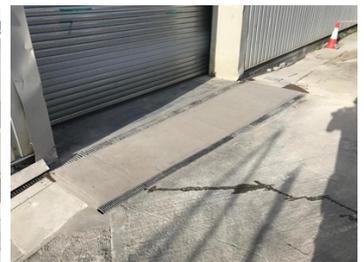
All complete and ready for production
