Concrete repair to roller shutter entrance repair

ID: 10079

Industry: General Industry
Application: FPA-Floor Problem Areas
Substrate: Concrete
Products: Belzona 4131 (Magma-Screed), Belzona 4911 (Magma TX Conditioner)

Customer Location: Alfreton
Application Date: September 2020

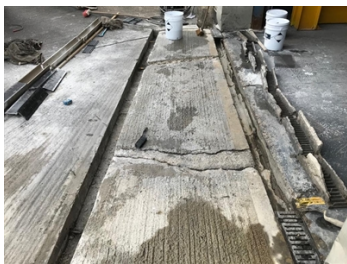
Constant heavy traffic had caused wear and damage to the apron leading toward the entrance of a large roller shutter door. The FLT were vibrating and unseating their loads, making the area dangerous for Forklift Traffic and anyone in the immediate area

Showing wear and heavy damage to the area

Break out all loose and friable

Vacuum the whole area

Apply Belzona 4911 as per Belzona 4131 IFU

Mix and apply Belzona 4131 as per Belzona 4131 IFU

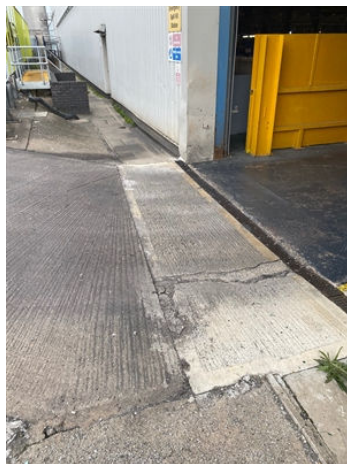
Further view of damage

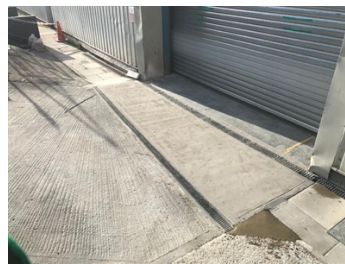
Completed repair using Belzona 4131

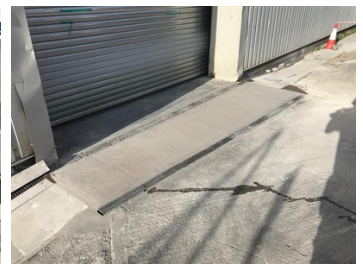
All complete and ready for production
