# BELZONA REPAIR TO INTERNAL ROOF DRAIN STILL OK 24 YEARS LATER

Industry: *Buildings & Structures*  
 Application: *VPF-Valves, Pipes and Fittings*  
 Substrate: *Steel and concrete*  
 Products: *\* Belzona® 4111 (Magma Quartz) ,*

Customer Location: *Auto manufacturer, Wentzville, MO*  
 Application Date: *Summer 1984*

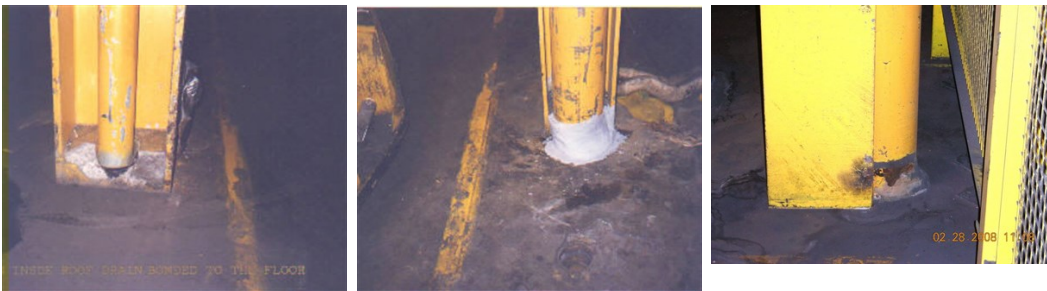
## Photograph Descriptions

*Hit by a fork lift truck, the pipe broke off at the floor level and leaked water everytime it rained.*

- \* Broken pipe, summer 1984 ,
- \* Repair completed ,
- \* Revisited February 2008 and still performing ,

Application carried out in accordance with a modified Belzona Know-How System Leaflet VPF-11b. Belzona® 4111 was packed around the break.

To change the broken pipe would involve a pipefitting/labor crew at least a week to excavate down below the floor three feet. Belzona application took just 20 minutes to complete. 8 man crew, 40 hours labor at \$50.00/hr = \$16,000 saved. Revisited February 2008, still performing.
