Warehouse cage repairs

ID: 10080

Industry: *Other* Customer Location: *Worksop*
Application: *TCC-Tanks and Chemical Containment Areas* Application Date:
Substrate: *Carbon steel*
Products: *Belzona 1111 (Super Metal), Belzona 9111 (Cleaner Degreaser)*

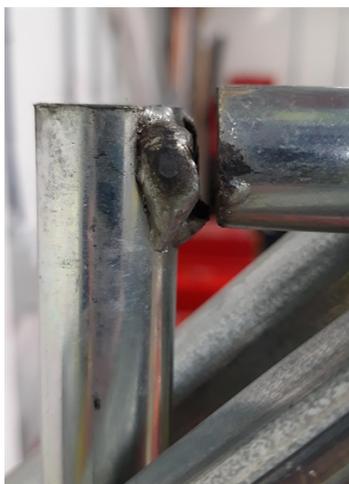
A large number of cages were failing at the welded joints and were virtually impossible to re weld to effect a conventional repair

Typical failed weld on a transportation cage

All areas were prepared using a mechanical grinder with cutting discs and flap discs
Belzona 9111 was used to clean and degrease the target areas' Belzona 9341 was used to reinforce the repair

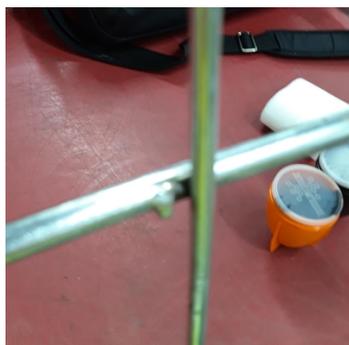
Other typical fails on welds due to general use and wear and tear

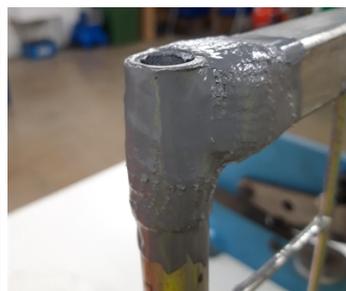
Belzona repair using Belzona 1111 and reinforcing sheet

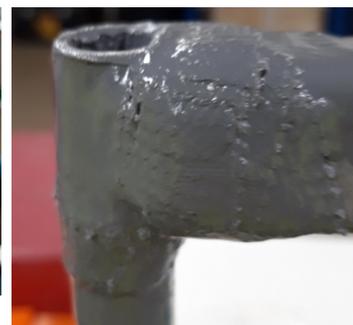
A further close up of the repair
