Steel Mill Sluice Repair by Belzona Composite Repair System in New Zealand

ID: 10081

Industry: Steel & Metal Processing
Application: SHM-Solids Handling Machinery

Substrate: Concrete
Products: Belzona 1321 (Ceramic S-Metal), Belzona 1812 (Ceramic Carbide FP), Belzona 4151 (Magma-Quartz Resin)

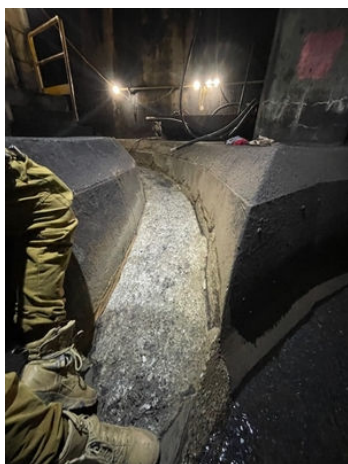
The condition of the concrete after the sluice had been drained and cleared of beards and grit.

1. The channel was dammed off, drained, and cleared of all debris. Five lineal meters were then grit-blasted in preparation for the application.
2. Belzona 4151 (Magma-Quartz Resin) was mixed with quartz sand in a resin-rich mixture and applied to the channel to restore its original geometry and create a smooth surface for the alumina tile system.

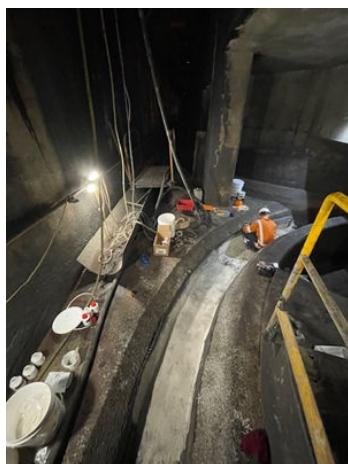
The channel was rebuilt using Belzona 4151 (Magma Quartz Resins) and locally sourced fine quartz sand and then lined with alumina tiles using Belzona 1321 (Ceramic S-Metal) as the adhesive.

3. Belzona 1321 (Ceramic S-Metal) was selected as the adhesive and applied to an average wet film thickness of 1000 microns.
4. The tile sheets were pressed into the Belzona 1321 until the entire 5-meter length was filled.

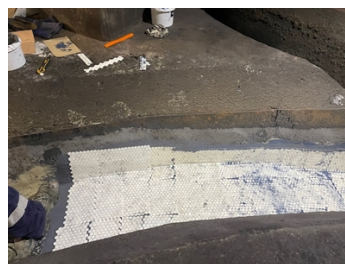
Once the Belzona 1321 (Ceramic S-Metal) had cured, the fabric backing was removed, and the area was frost-blasted in preparation for grouting with Belzona 1812 (Ceramic Carbide FP).

5. Once cured, the fabric backing and any loose tiles were removed. The area was then frost-blasted and cleaned with compressed air.
6. Belzona 1812 (Ceramic Carbide FP) was applied as a grout and used to create transitional areas between the tile sheets and the channel to prevent future beads from jamming or cutting under the tiles.

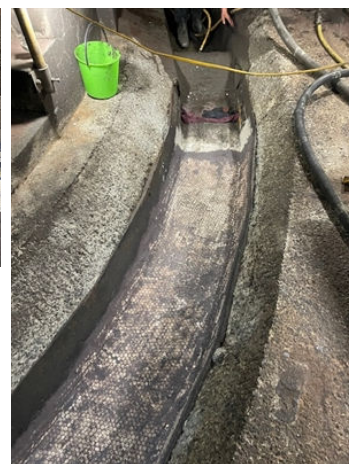
Once the grouting was complete, a feather edge of Belzona 1812 (Ceramic Carbide FP) was applied to create a transitional area between the tiles and the channel, helping to prevent future buildup of beards.
