Belzona Elastomers for Fender Repair in New Zealand

ID: 10083

Application: SOS-Ships and Offshore Structures

Customer Location: Auckland Port

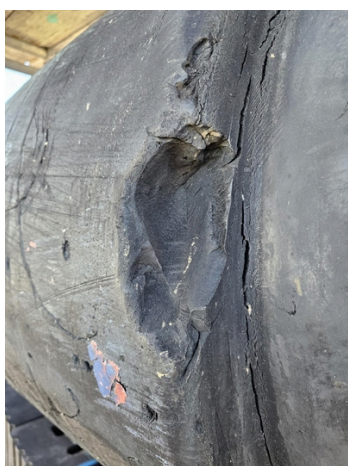
Large tears and gouges reduced the efficacy of the Fender and caused ropes to become caught
