Belzona Repairs Staircase of 79-Meter-Diameter Crude Oil Storage Tank

ID: 10087

Application: TCC-Tanks and Chemical Containment Areas

Application Date: April 2015

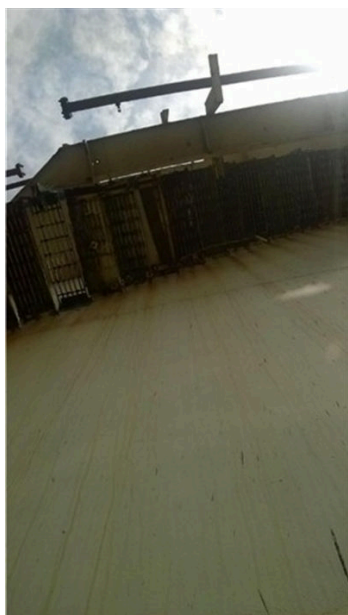
The staircases and steel gratings had sustained significant structural damage due to atmospheric and localized corrosion. Sections of the stairs were visibly detaching from the tank shell, posing serious safety and operational risks.

The staircase of the 79-meter-diameter crude oil storage tank was damaged.

1. Mechanical cleaning using non-sparking tools to remove loose corrosion and contaminants.
2. Degreasing the application surface with Belzona 9111 Cleaner/Degreaser.
3. Repairing the damaged gratings and repositioning the dislodged stairs, which were structurally bonded to the tank shell using Belzona 1161 Super UW Metal.
4. Allowing the repair to cure for 24 hours.

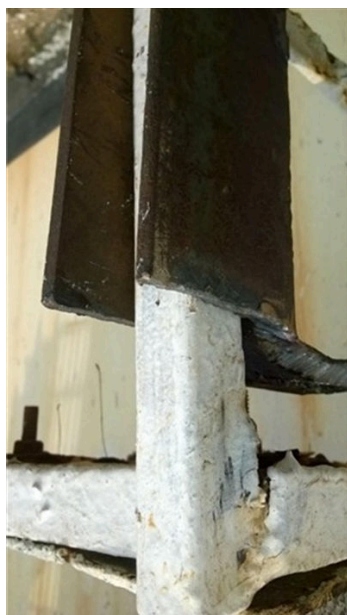
The stair fixing arrangement was carefully designed to ensure safety and structural stability.

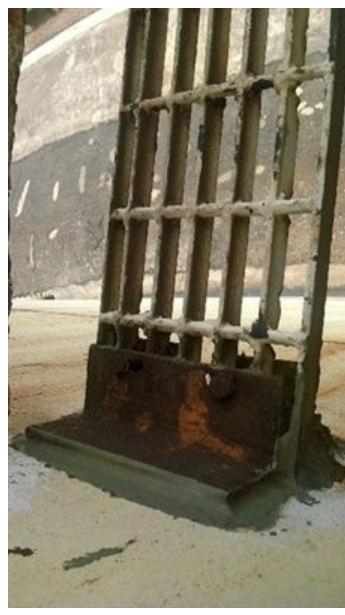
The grating stair was securely fixed to the tank shell.

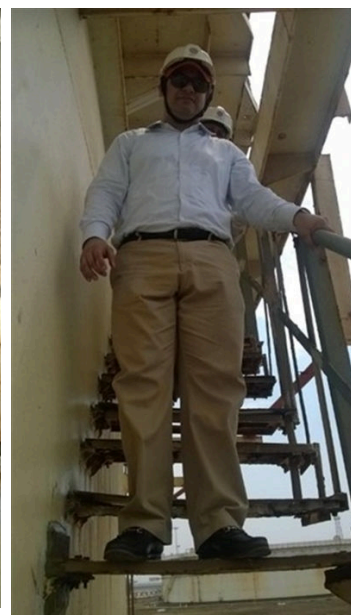
The stairs were fixed and tested with a human trial.
