Belzona cooling tower basin repair

ID: 10091

Customer Location: Hamilton, ON.

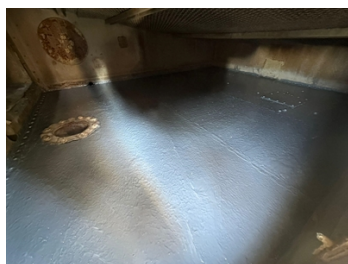
Cooling tower basin was experiencing deterioration and required a face lift.

Basin before repair

Power tool cleaning was carried out on the surface before the pitting was covered with Belzona 1161. Two coats of Belzona 5831 was then applied afterwards.

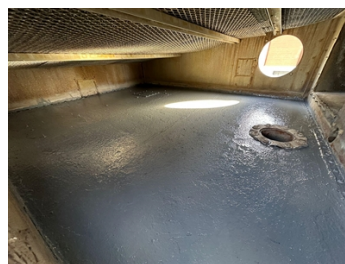
Basin after repair

Completed application
