20" Crude Oil Line Repair Using Belzona Non-Compliant SuperWrap II

ID: 10094

Industry:	Oil & Gas	Customer Location:	Al Jhaffi
Application:	VPF-Valves, Pipes and Fittings	Application Date:	July 2025
Substrate:	Carbon steel		
Products:	Belzona 1221 (Super E-Metal), Belzona 1983 (SuperWrap II), Belzona SuperWrap II, Belzona 9611 (ES-Metal)

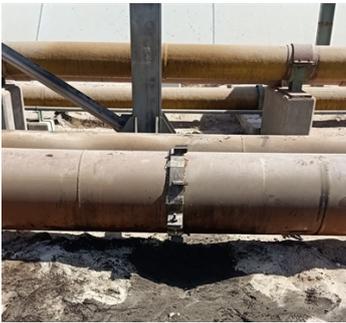
The 20" pipe was clamped by the customer due to severe leakage.

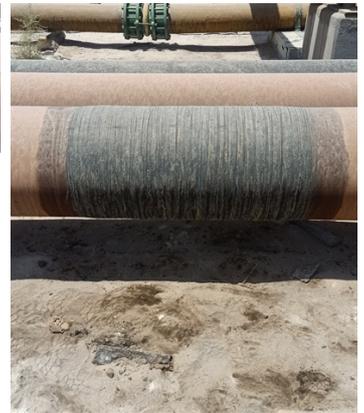
After successful application of Belzona SuperWrap II (3 wraps)

No leaks were observed in the Belzona SuperWrap II repair after four months of service.

Belzona surface-tolerant materials were first applied to seal the active leak and stabilize the affected area. Once the LEL level reached zero, surface preparation was carried out by grit blasting to Sa 2½, achieving a minimum 75-micron surface profile. A non-compliant Belzona SuperWrap II system, using Belzona 1983 resin and Belzona 9381 carbon-glass fiber reinforcement, was then applied in three wraps. The wrap was consolidated with Belzona 9382 release film and allowed to cure before the film was removed.

After four months, the repair was inspected and found to be completely intact with no leaks, further enhancing the customer's trust and confidence in Belzona solutions.
