Belzona Seals Concrete Leak in External Stairwell to Protect Hospital

ID: 10098

Application: WPA-Wall Problem Areas

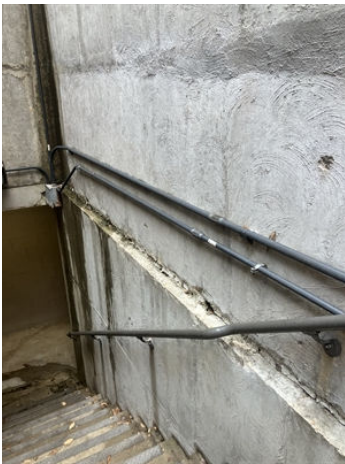
This image shows the leak externally in the vertical and horizontal joint of the wall.

1. Surface prep was done by using a handheld grinder with a 7" turbo cup diamond grinding disk attachment to roughen the surface.
2. Belzona 9611 was used to plug leaking defects in the vertical joint.
3. Belzona 4911 conditioner was applied on the horizontal joint.

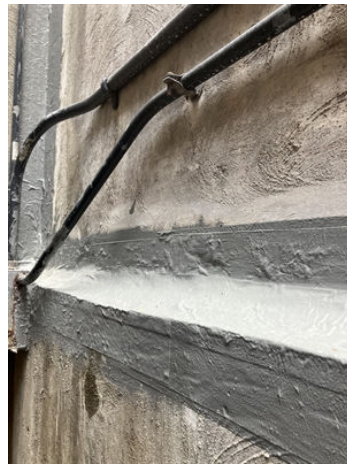
This is a close up on the 3121/9331 repair on the horizontal and vertical joints, after the job was completed.

5. Belzona 3121 and 9331 were applied to composite patch the vertical and horizontal joints.

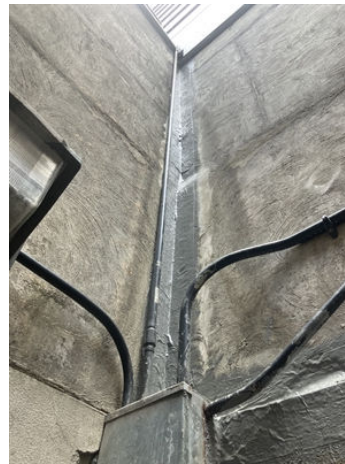
Close up on the vertical joint after the application was completed.
