# BELZONA REPAIR AND PROTECTION OF STABILISER SHAFT

ID: 101

Customer Location: *Shipping Company, Monaco*  
Application Date: *1995*

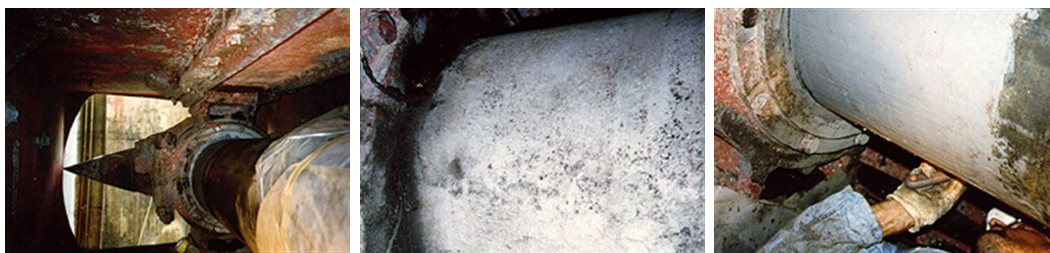
## Photograph Descriptions

*Severe pitting corrosion in-board of bearing.*

- \* General view of the stabiliser shaft ,
- \* After grit blasting, degree of erosion-corrosion damage clearly evident ,
- \* Application of Belzona® 1111 being completed ,

Application was carried out in accordance with Belzona System Leaflet SOS-1.

Belzona was used because our repair could be done without dismantling.
