BELZONA RESURFACES LAB TABLES

ID: 1010

Application: FPA-Floor Problem Areas

Customer Location: Atlanta, GA, USA

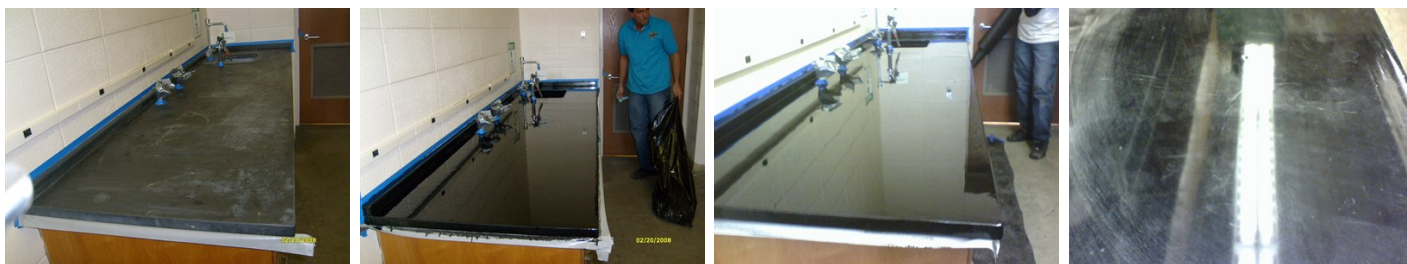
At Georgia Tech, customer wanted to provide a durable surface without having to replace soapstone tables of 40 years of wear and tear have degraded tables.

- * 1. View of original table ,
- * 2. Application of first coat ,
- * 3. Completed application ,
- * 4. After 5 years, another lab top table was being repaired. Lab was being rebuilt, but the tops were remained. ,

Sanding tables to provide a good profile. Then applied two coats of Belzona 5811.
