# Belzona 5871 Solves CUI Problem at Refinery

ID: 10101

Industry: Chemical & Petrochemical  
Application: VPF-Valves, Pipes and Fittings  
Substrate: Carbon steel  
Products: Belzona 5871

Customer Location: Huelva  
Application Date: October 2024

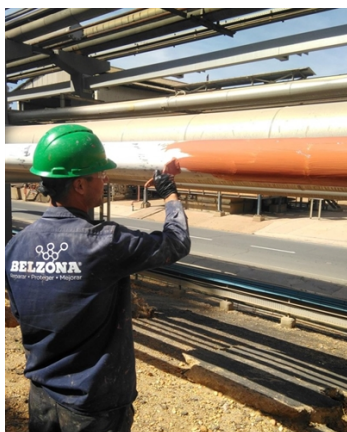
A refinery contacted us to solve a CUI (Corrosion Under Insulation) problem with their carbon steel pipeline. The pipeline had been in operation for 20 years, 24 hours a week and had a very high corrosion status which had caused loss of thickness, causing perforations and therefore benzene to leak out from the pipeline.

Damaged pipeline

After mechanical tests carried using Belzona 5871, the refinery opted to manufacture a new 700-metre-long carbon steel line, parallel to the old line, and to coat this new 6" and 700 m line with Belzona 5871.

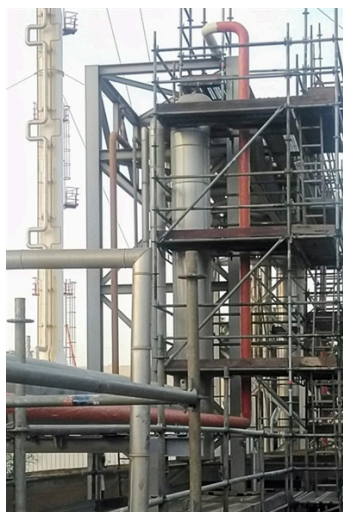
Belzona 5871 being applied to new pipeline

Using the Instructions for Use, Belzona 5871 was brush applied to the new pipeline.

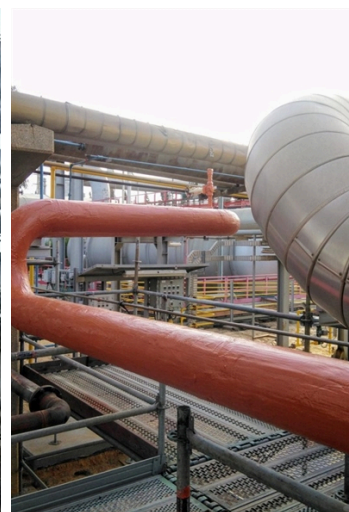
Completed application
