Belzona 5871 Solves CUI Problem at Refinery

Industry: Chemical & Petrochemical
Application: VPF-Valves, Pipes and Fittings
Substrate: Carbon steel
Products: Belzona 5871

Customer Location: Huelva
Application Date: October 2024

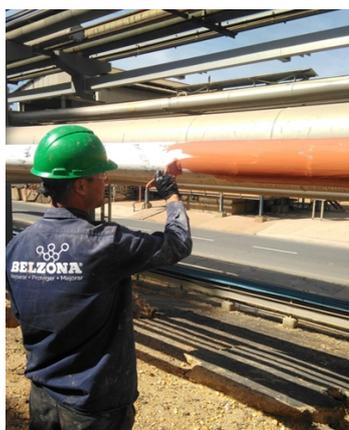
A refinery contacted us to solve a CUI (Corrosion Under Insulation) problem with their carbon steel pipeline. The pipeline had been in operation for 20 years, 24 hours a week and had a very high corrosion status which had caused loss of thickness, causing perforations and therefore benzene to leak out from the pipeline.

Damaged pipeline

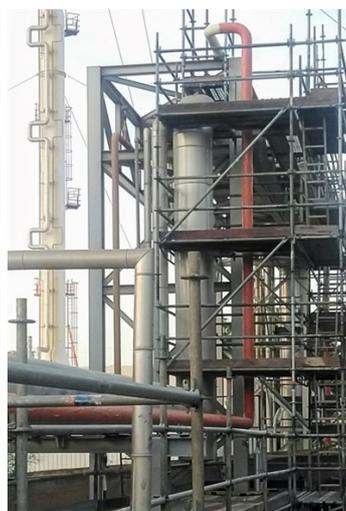
Belzona 5871 being applied to new pipeline

Using the Instructions for Use, Belzona 5871 was brush applied to the new pipeline.

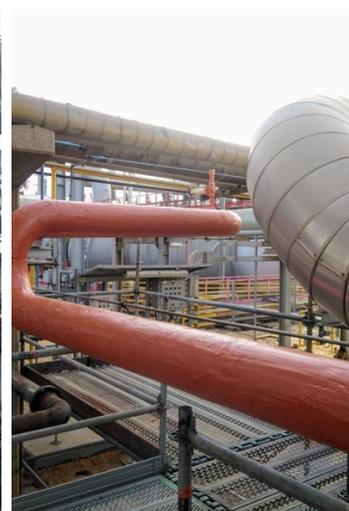
Completed application

After mechanical tests carried using Belzona 5871, the refinery opted to manufacture a new 700-metre-long carbon steel line, parallel to the old line, and to coat this new 6" and 700 m line with Belzona 5871.
