Belzona 1813 saves fiberglass spray headers

ID: 10104

Customer Location: Beulah, North Dakota
Application Date: May 2020

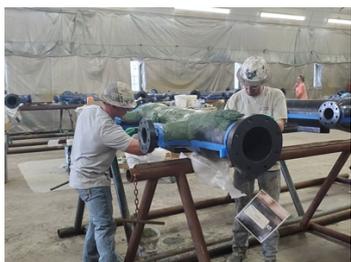
Application of Belzona 1813 to new headers in their shop.

The application was done on new piping now in contractors shop. The top half of all new piping was prepped manually and 1/8 to 1/4 inch Belzona 1813 was applied. Initially the repairs were done inside tank and new piping was ordered. The Belzona 1813 worked so great that they wanted the new piping coated as well.

New fiberglass piping was manually prepped with grinders, cleaned and Belzona 1813 was applied by hand.

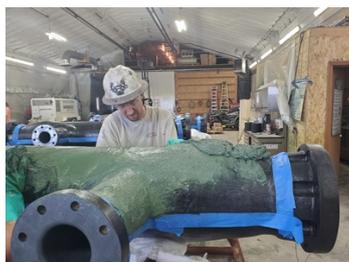
Smoothing out the Belzona 1813 on headers.

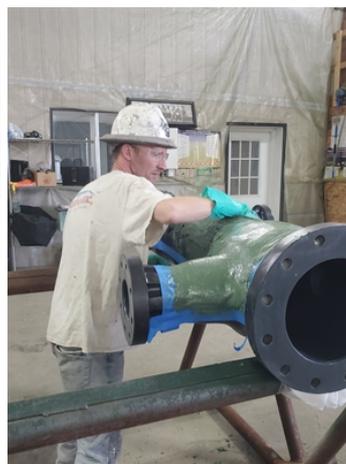
Closeup of contractor finishing up on a header.

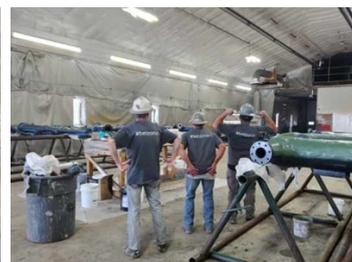
Finalized application and contractors wearing new Belzona t-shirts!
