# Belzona 1813 saves fiberglass spray headers

ID: 10104

Industry: Oil & Gas  
Application: TCC-Tanks and Chemical Containment Areas  
Substrate: Composite  
Products: Belzona 1813

Customer Location: Beulah, North Dakota  
Application Date: May 2020

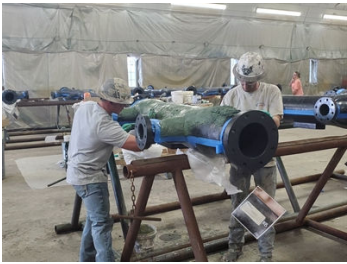
Application of Belzona 1813 to new headers in their shop.

The application was done on new piping now in contractors shop. The top half of all new piping was prepped manually and 1/8 to 1/4 inch Belzona 1813 was applied. Initially the repairs were done inside tank and new piping was ordered. The Belzona 1813 worked so great that they wanted the new piping coated as well.

New fiberglass piping was manually prepped with grinders, cleaned and Belzona 1813 was applied by hand.

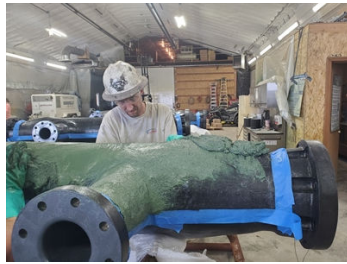
Smoothing out the Belzona 1813 on headers.

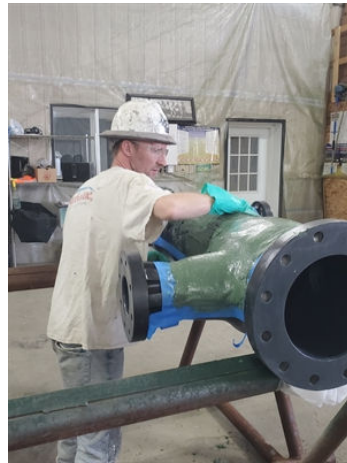
Closeup of contractor finishing up on a header.

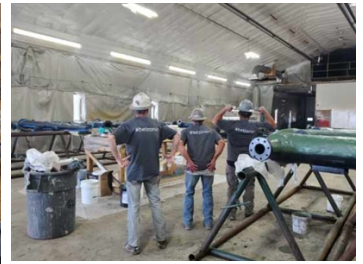
Finalized application and contractors wearing new Belzona t-shirts!
