# Belzona Restores a Chiller with Failed Competitor Coating

ID: 10105

Application: HEX-Heat Exchangers

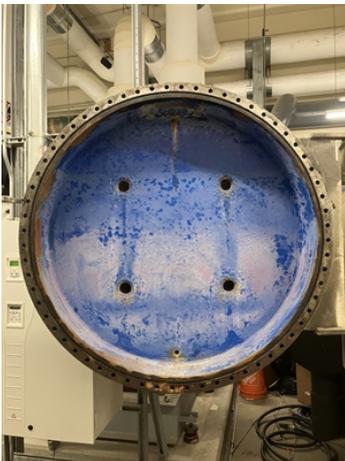
End cover, with delaminated enecon coating. Water is under the coating causing blisters/bubbling up near the anodes.

3. Tubes were corked. Abrasive blasting was completed, per SSPC-SP10. We used emerald grit and a dry blast. We blasted away the failed coating and achieved 3mil profile on metal substrate.
4. Belzona 9111 was used to solvent wipe.
5. A few small locations needed Belzona 1121 to be applied as pit fill and rebuild lost metal.
6. Belzona 1321 was applied in a two coat system.
7. Corks removed and touch ups applied as needed.
8. Coating allowed to cure and returned to service.

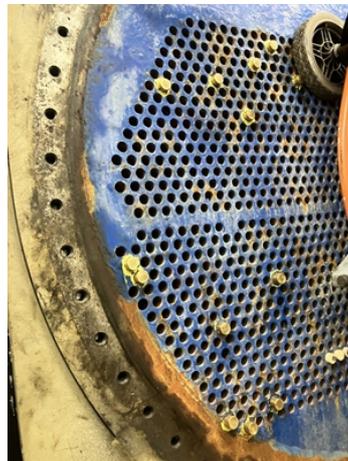
Close up image of the tube sheet showing failed enecon coating with creep corrosion around circumference.

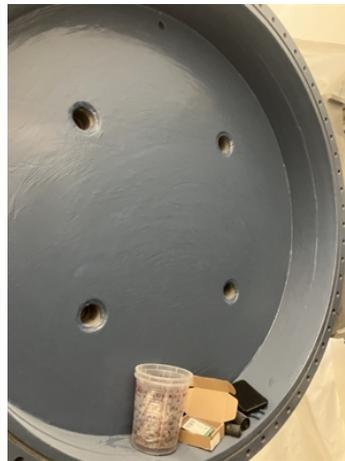
Belzona 1321 applied on the end cover

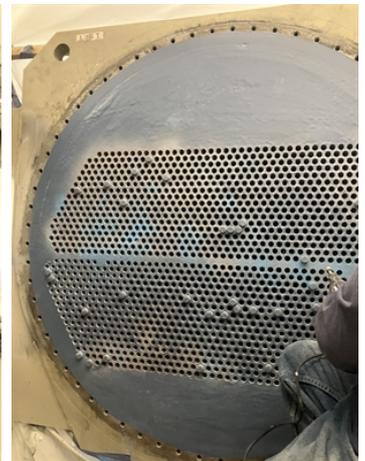
Belzona 1321 applied on the tube sheet
