Belzona Repairs Glass Lined Manway Cover during a Turnaround

ID: 10106

Application: VPF-Valves, Pipes and Fittings

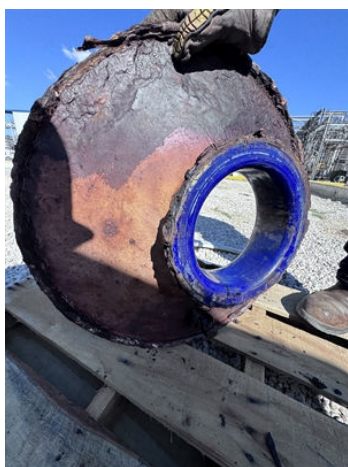
The customer has a large glass lined tank with a manway cover that experienced external corrosion from a leak dripping on it, and chipping to the glass lining at the sealing area. The neck of the nozzle experienced pitting and made it difficult to reattach the flange to create a proper seal. Also, the outer lip was almost gone due to corrosion, which created issues when trying to seal with clamp. They noticed this during a turnaround, so time was limited for a return to service for them to stay on schedule.

Before image of the manway cover

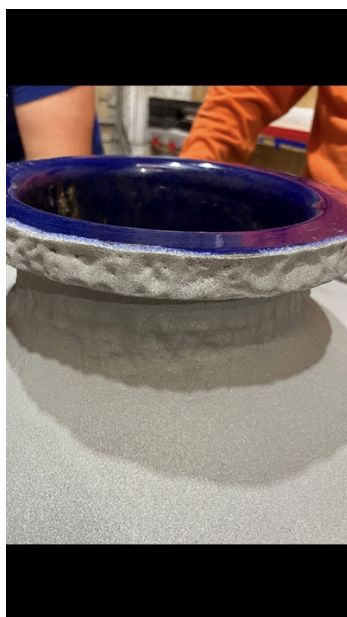
After abrasive blasting the externals, SSPC-SP10

1. Abrasive blasted the external of the manway cover, SSPC-SP10. Solvent wipe with Belzona 9111.
2. We hand sanded some of the glass lining at the sealing surface, so we can tie into with coating. We did not grit blast the glass.
3. Applied Belzona 1511 by stiff bristled brush & applicator to rebuild pitting and help create a smooth neck/nozzle for the flange to reattach.
4. Applied two coat system of Belzona 1593.
5. Customer applied UV resistant paint in the field.

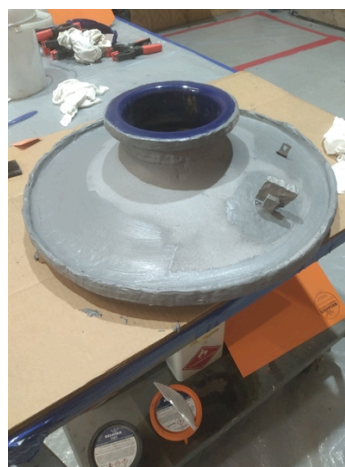
Rebuild with Belzona 1511 to create the proper lip around the circumference and rebuild pitting on the neck.

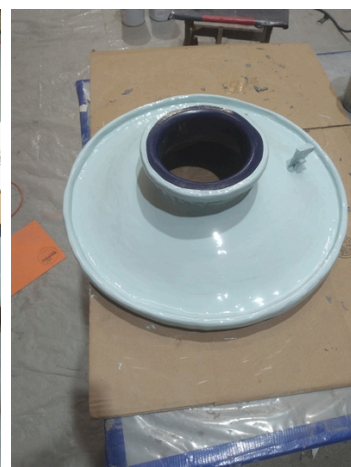
After Belzona 1593 was applied to provide corrosion protection

Belzona 1511/1593 were chosen due to their ability to handle high temps and chemical resistance. The asset ran at elevated temperatures and the previous external corrosion is expected to be caused by a chemical spill from neighboring asset onto the manway. Our quick return to service, material in stock in town, turn key capabilities, and quality craftsmanship is what led the customer to choosing Belzona.
