Ramps and Landings with Belzona 4151

ID: 10108

Application: FPA-Floor Problem Areas

Customer Location: Decatur, AL

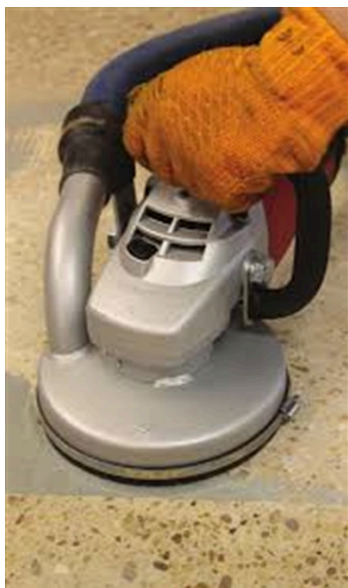
We first cleaned and prepared the concrete using surface grinders.

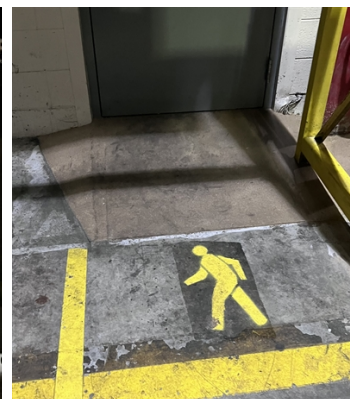
To finish, we removed the forms after the recommended cure time and opened the doorway back up to pedestrian traffic.
