# Water Leak in a Spool

ID: 10109

**Application:** VPF-Valves, Pipes and Fittings

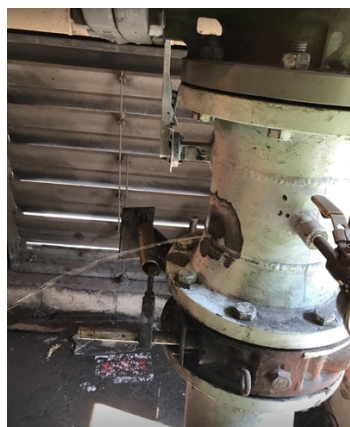
The spool had deteriorated over the years and created a wear area that caused a leak.

Assessing the situation before beginning. You can see the live leak. This is where we came up with the plan to stop the leak using Belzona 9611 and 1111 with reinforcement cloth.

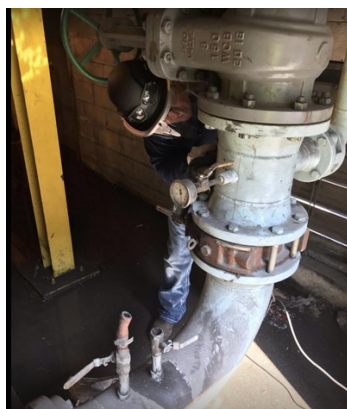
Next we cleaned and prepped the surface area using a MBX Bristle Blaster to create a profile for the Belzona to adhere to.

We used 100% MEK to clean the surface with followed by a MBX Bristle Blaster to prep the surface area. We used the applicator pad provided by Belzona to apply the 1111.

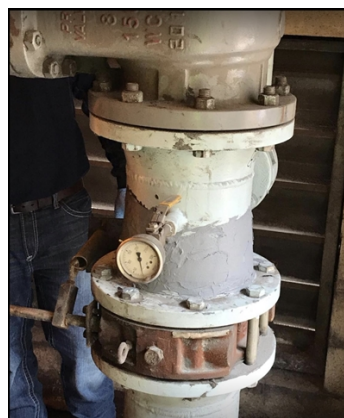
Once the preparation was completed we used Belzona 9611 in the form of a Hershey Kiss and plugged the hole and applied a tourniquet to hold the 9611 in place for about 10-15 minutes.

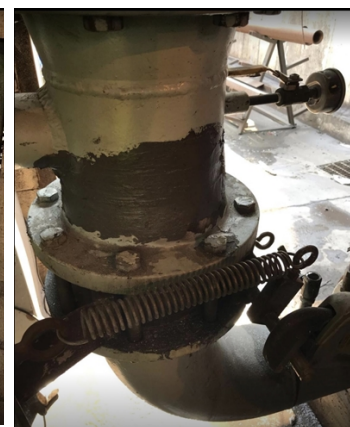
To complete the application, we applied Belzona 1111 to the surface area and to the reinforcement cloth and wrapped the entire spool.
