# Propeller Repair & Coating

Application: CEP-Centrifugal Pumps

Substrate: Carbon steel

Products: Belzona 1111 (Super Metal), Belzona 1321 (Ceramic S-Metal)

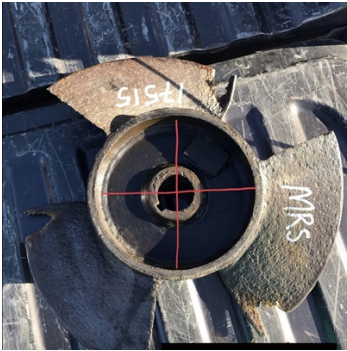
This propeller had seen years of pumping water out of a slough due to high water during rain or Beaver dams backing the water up. The propeller had seen water, tree limbs and rock that caused the damage.

This picture is of the damaged propeller.

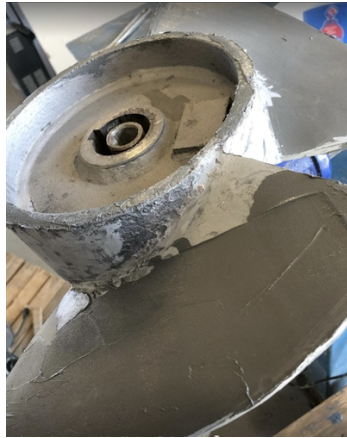
Once we cleaned and grit blasted the propeller we started making the repairs using Belzona 1111.

We cleaned the propeller using 100% MEK followed by grit blasting to a 3 mil profile. We used the provide tools from Belzona to apply the Belzona 1111 and a stiff brush to apply the Belzona 1321.

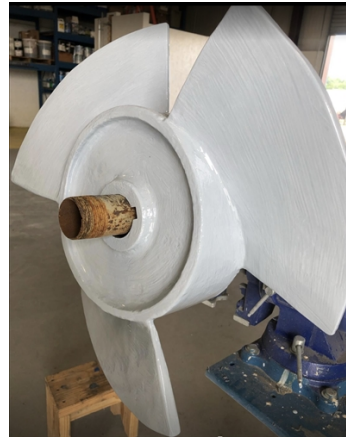
This is after repairs were made and the application of the first coat of Belzona 1321.

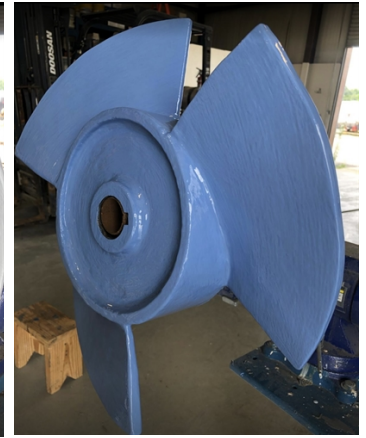
In this picture you have the completion of the repairs and coating using Belzona Super Metal 1111 for the repairs and Belzona 1321 Ceramic Coating.
