Main Condenser Expansion Joint Saved

ID: 10115

Industry: *Power*

Customer Location: *Underwood, North Dakota*

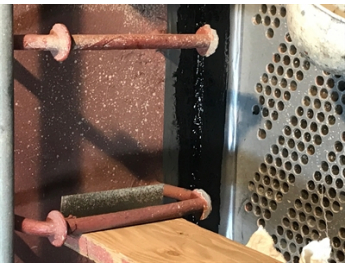
Closeup of Belzona 2111 elastomer expansion joint in main condenser

The joint area was blasted and cleaned, Belzona 2911 was applied on entire surface area, and the Belzona 2111 reinforced system application was carried out during outage.

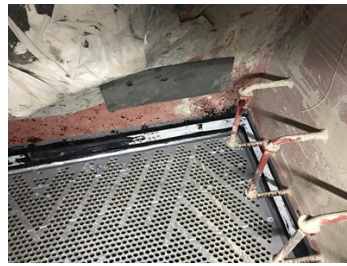
Belzona 2111 application reinforced with reinforcement mesh replacing expansion joint

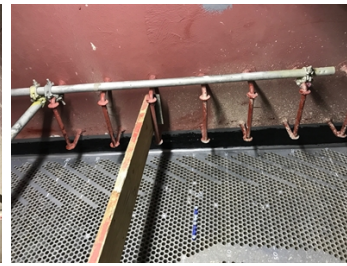
Close-up of final expansion joint using Belzona 2111 elastomer

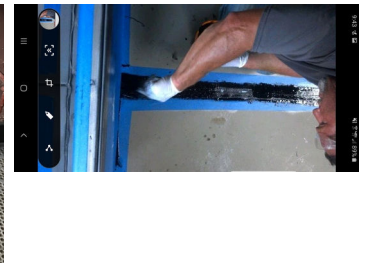
Belzona 2111 completed application
