Chiller Internal Rebuild and Protection with Belzona 1121 & 1321

ID: 10117

Application: HEX-Heat Exchangers

Customer Location: Orlando, Florida – Universal Studios

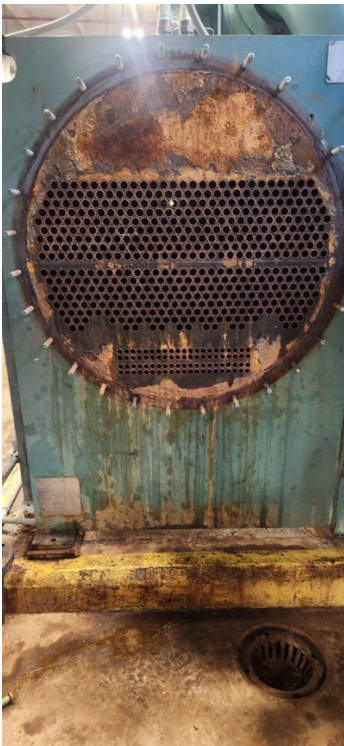
Severe corrosion present on the tube sheet of the YORK MaxE chiller, showing metal loss, scaling, and deterioration around the tube openings prior to surface preparation.

The surfaces were prepared by abrasive blasting to SSPC-SP10 (Near White Metal), achieving a clean profile suitable for Belzona adhesion. Dust and contaminants were removed using clean, dry air.

Belzona 1121 was then applied by hand using applicators and spatulas to rebuild areas of metal loss on the tube sheet and end cover. The material was worked into the substrate to ensure full wet-out and restored geometry.

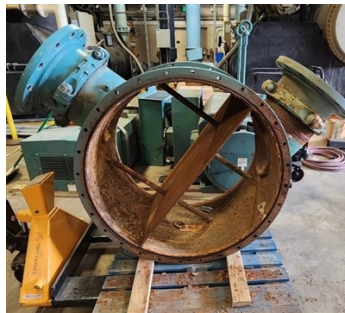
Internal corrosion inside the diffuser and water box area of the YORK MaxE chiller, showing severe rusting, pitting, and metal degradation before blasting and rebuilding.

Once curing allowed, Belzona 1321 was applied in two coats using brushes and smoothers to create a uniform, corrosion-resistant lining on the diffuser, water box, and rebuilt areas. Wet film thickness checks were performed throughout the process to ensure correct coverage.

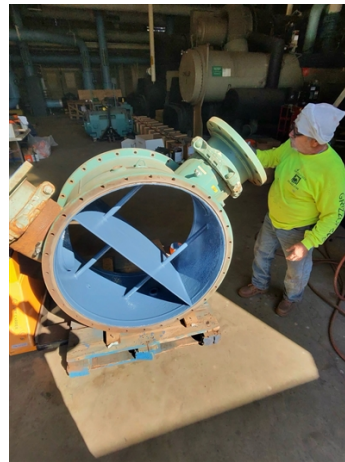
Diffuser section after surface preparation, rebuilding, and full application of Belzona 1321, providing a smooth, durable erosion- and corrosion-resistant lining.

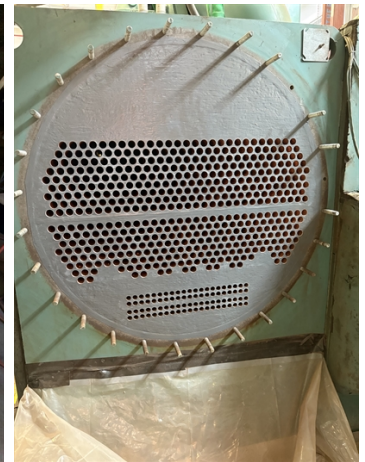
Tube sheet restored with Belzona 1121 for rebuilding and fully coated with Belzona 1321 to provide long-term protection against corrosion and erosion. Surface restored to a smooth, uniform finish ready for reassembly.
