# Belzona 1341 Ensures Reliable Heat Exchanger Performance During a Major Turnaround

Application: HEX-Heat Exchangers

Customer Location: Saudi Arabia

Application Date: May 2025

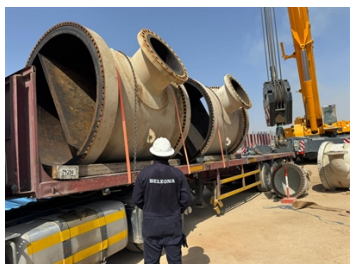
General Overview of the Cooling Water Channel Heads

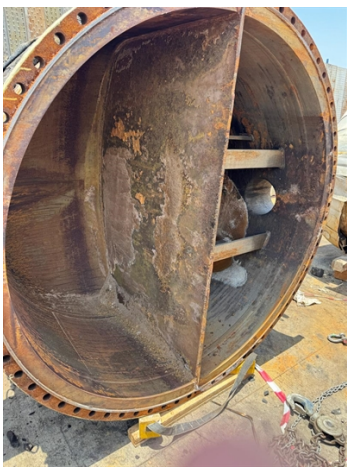
The customer was experiencing corrosion and erosion on the channel heads of cooling water heat exchangers. Over time, this resulted in metal loss, pitting, and surface deterioration, compromising the integrity of the equipment, increasing the risk of leakage, and reducing overall heat transfer efficiency.

A heat exchanger channel head in a petrochemical plant had suffered significant corrosion-erosion, resulting in wall-thickness loss.

The heat exchanger channel head repair was carried out using Belzona 1111 (Super Metal) and Belzona 1341 (Supermetalglide), following the steps outlined below:

- Surface preparation was performed by grit blasting to achieve the required surface profile, followed by thorough cleaning with Belzona 9111 (Cleaner Degreaser).

- Belzona 1111 (Super Metal) was then applied to rebuild the damaged areas.
- Belzona 1341 (Supermetalgilde) was subsequently applied to provide a smooth, corrosion-resistant protective coating.

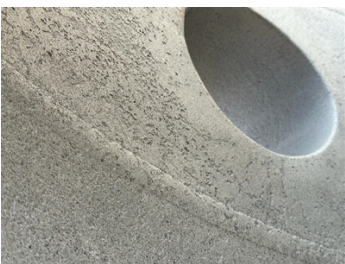
After Grit Blasting Surface Preparation

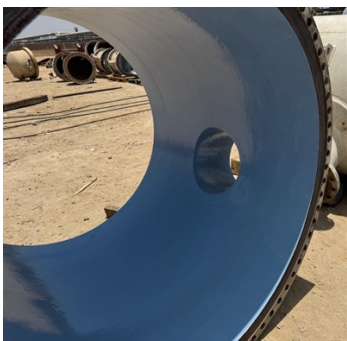
Completed application of Belzona 1341 (Supermetalglide) on the heat exchanger channel head.

All work was completed under controlled conditions to ensure proper adhesion and long-term performance.
