BELZONA SAVES REFINERY \$50,000

Application: HEX-Heat Exchangers

Customer Location: Refinery - Sweeny, Texas USA

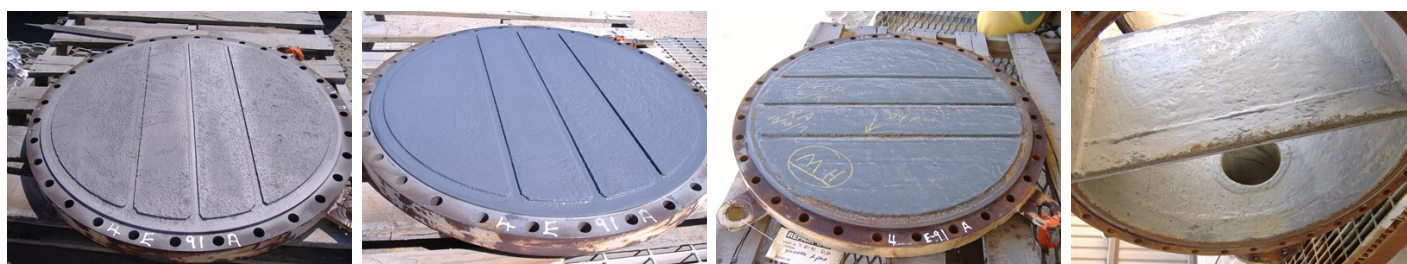
Photograph Descriptions

Galvanic corrosion and erosion resulting in loss of thickness and gasket sealing surfaces. This allows for working fluid to bypass portions of the multi-pass exchanger thereby greatly decreasing the efficiency of the heat exchanger.

- * Heat exchanger dollar plate prior to repair ,
- * Heat exchanger dollar plate after repair and coating ,
- * Heat exchanger after five years in service ,
- * Heat exchanger channel head after five years in service ,

Multiple heat exchanger components severely damaged by erosion/corrosion.

Belzona® 1111 and Belzona® 1321 were applied in accordance with Belzona Know-How System Leaflet HEX-2.

Conventional repair involves weld build up followed by the machining of new gasket surfaces at a cost of \$2,500-\$5,000 per dollar plate. The Belzona solution costs less than half of the conventional repair. This results in cost savings of more than \$50,000 per unit turnaround.
