# Secondary Containment Repair & Coating

ID: 10134

**Industry:** Chemical & Petrochemical  
**Application:** TCC-Tanks and Chemical Containment Areas  
**Substrate:** Concrete  
**Products:** Belzona 4111 (Magma-Quartz), Belzona 4311 (Magma CR1), Belzona 4911 (Magma TX Conditioner)

**Customer Location:** Decatur, AL  
**Application Date:** June 2022

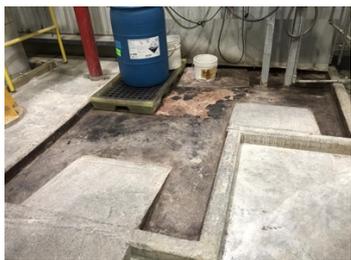
The client was facing deteriorating concrete due to chemical spillage when replacing the chemical storage container.

You can see the damaged concrete areas in this picture from the chemical spillage.

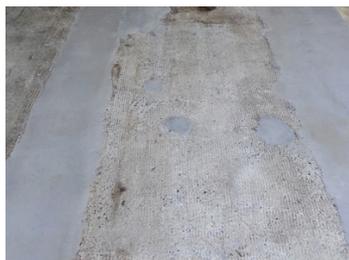
We had to make a few deeper concrete repairs using Belzona 4111 before moving forward.

We first began by neutralizing the affected area. Then we began to remove loose and damaged concrete with needle guns and hand grinders. Once the damaged areas were prepped we began to apply Belzona 4911 Conditioner followed by Belzona 4111 to fill pockets of damaged areas followed by skimming the containment area to level the floor and for proper drain. Next we applied two coats of Belzona 4311 to the containment and curbing and providing a little extra protection by carrying the coating over the curbing and ramp.

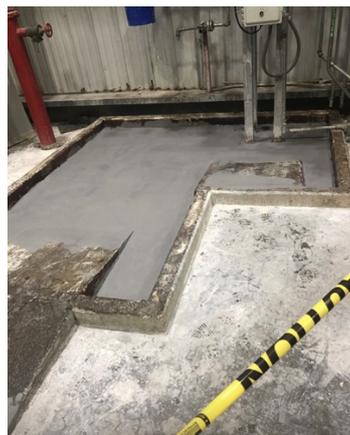
Once the other areas had been repaired we skimmed most of the containment area to bring back to level using Belzona 4111

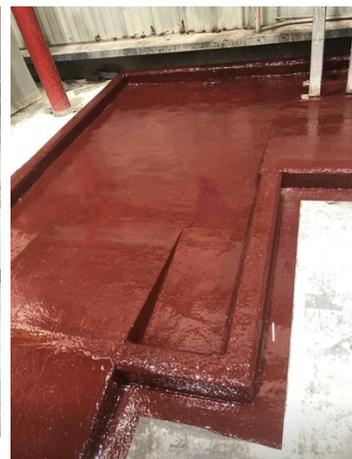
Here you can see the completed application using Belzona 4311 due to high concentration of chemical.
