Belzona Restores HEX Tube Sheet to Prevent Leak

ID: 10136

Application: HEX-Heat Exchangers

Substrate: Carbon steel

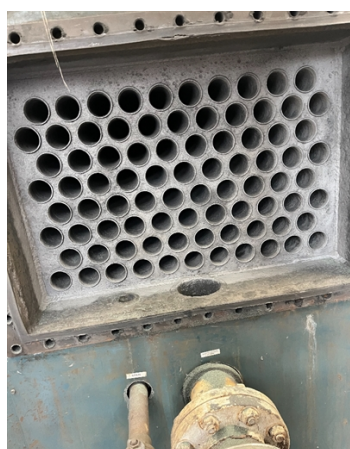
After abrasive blasting
SSPC-SP10

1. Customer opened and drained the asset. They applied a fan on the tube sheet to dry the tubes.
2. Corks were applied to the tubes. We abrasive blasted the tube sheet per SSPC-SP10. Wiped it clean with Belzona 9111 degreaser and let dry.
3. Belzona 1511 was used to pit fill the tube sheet.
4. Belzona 1391T was applied in a two coat system.
5. Product allowed to cure and returned to service.

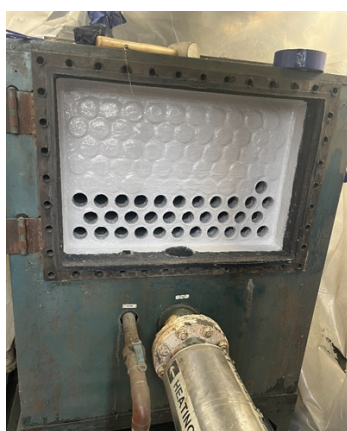
Pit fill and first coat applied of
1391T. Corks still in place.

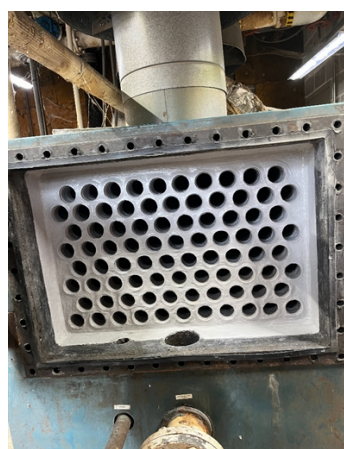
Corks removed and final touch
ups completed.

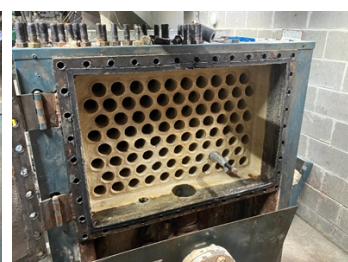
Image is after 1 year of service.
Still in good condition.

The Belzona solution saved the customer downtime and replacement cost. After 1 year we were able to open and inspect the coating. The Belzona was still in good condition. Originally they were going to use the Belzona to buy them time to get a new asset, but after inspecting the Belzona at the 1 year mark they plan to continue as is. The customer did apply another layer of coating themselves, to touch it up since it was open, before returning it back to service.
