# Belzona Restores HEX Tube Sheet to Prevent Leak

ID: 10136

**Application:** HEX-Heat Exchangers

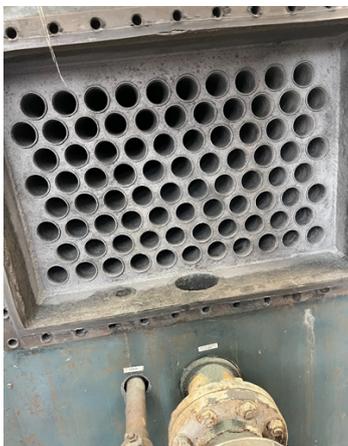
After abrasive blasting  
SSPC-SP10

1. Customer opened and drained the asset. They applied a fan on the tube sheet to dry the tubes.
2. Corks were applied to the tubes. We abrasive blasted the tube sheet per SSPC-SP10. Wiped it clean with Belzona 9111 degreaser and let dry.
3. Belzona 1511 was used to pit fill the tube sheet.
4. Belzona 1391T was applied in a two coat system.
5. Product allowed to cure and returned to service.

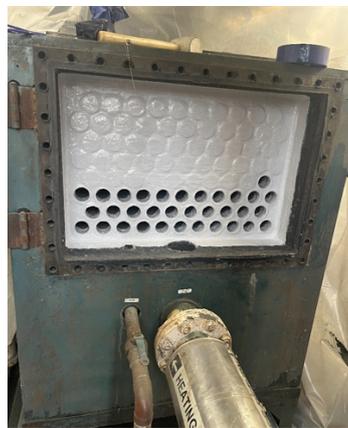
Pit fill and first coat applied of  
1391T. Corks still in place.

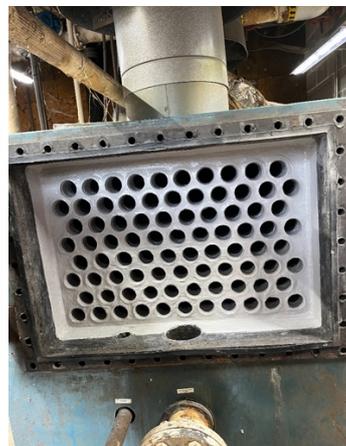
Corks removed and final touch  
ups completed.

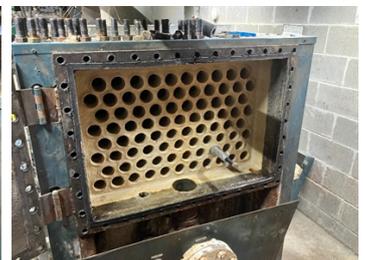
Image is after 1 year of service.  
Still in good condition.

The Belzona solution saved the customer downtime and replacement cost. After 1 year we were able to open and inspect the coating. The Belzona was still in good condition. Originally they were going to use the Belzona to buy them time to get a new asset, but after inspecting the Belzona at the 1 year mark they plan to continue as is. The customer did apply another layer of coating themselves, to touch it up since it was open, before returning it back to service.
