Belzona Restores a Cone Shaped Cyclone Separator

ID: 10137

Customer Location: Greater Houston, TX
Application Date: June 2025

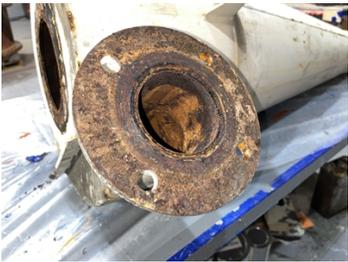
The customer had a cyclone separator that constantly vibrates to separate solids inside. The process over time eroded the metal and created through wall defects. The cost & time for a replacement was not feasible. Weld repair was not possible because the asset had thin metal and a unique geometry. The customer was looking for a cost effective solution that allowed a quick return to service.

Before image of a flange and externals

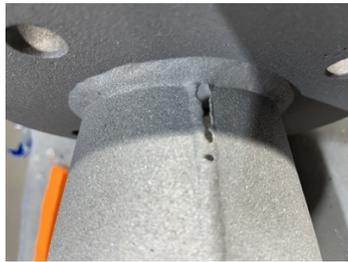
Pin holes found after blasting

1. The asset was sent to our shop for work to be done over a weekend.
2. The asset was abrasive blasted to SSPC-SP10 standard and wiped clean with Belzona 9111 degreaser.
3. Belzona 1311 paste was applied to plate bond over any through wall defects, pit fill, and smooth welds as needed.
4. Belzona 1311 was applied by hand to rebuild the flange faces to create a flat surface. After dimensionally stable, the 1311 was sanded flush best effort.
5. Belzona 1381 was applied in a two coat system to the internals of the asset.
6. Belzona 1381 was applied with 9341 mesh to composite wrap the bottom 24" externally, and the top nozzle.
7. Visual inspection and touch ups completed. Product was allowed to cure, and returned to customer.

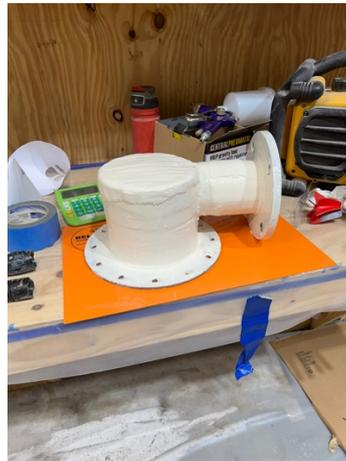
External repair completed on the top nozzle piece

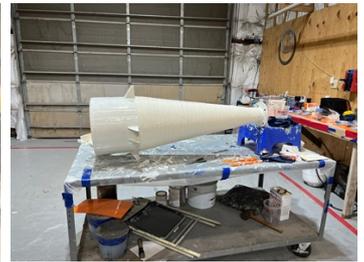
External repair completed on the main body of the separator
