Cooling Tower Pipe Coating

ID: 10139

Industry: Steel & Metal Processing
Application: VPF-Valves, Pipes and Fittings
Substrate: Carbon steel
Products: Belzona 5831 (ST-Barrier)

Customer Location: Decatur, AL
Application Date: September 2024

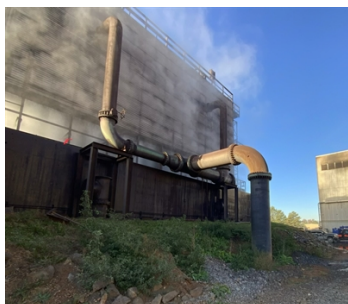
The client was facing deterioration on their exterior piping to the cooling tower from years of exposure to the elements without a coating.

Exterior cooling tower piping before any prep or Belzona coating.

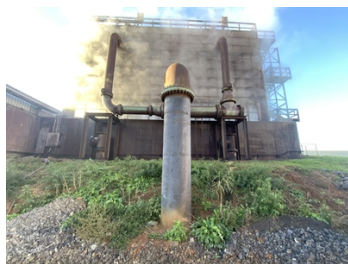
Photo after pressure washing only.

We used a normal pressure washer to surface prep the pipe followed by a wire wheel to remove heavier rust in some areas. Next we cleaned the pipe using 100% MEK. Then we applied the Belzona 5831 using half inch nap rollers to ensure the coating was applied thoroughly and absorbed in the deeper pitted areas.

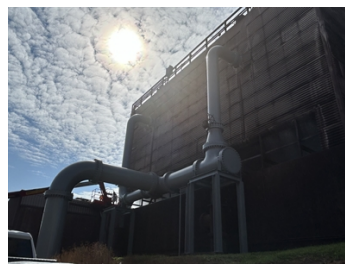
After applying Belzona 5831

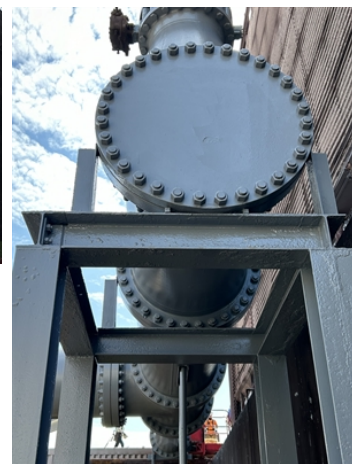
Close up of Belzona 5831
